International Panel of Experts

Safety of Nenskra Hydropower Project - Georgia

STAGE II REPORT - Part 2 & Final

Date: 27 February 2017

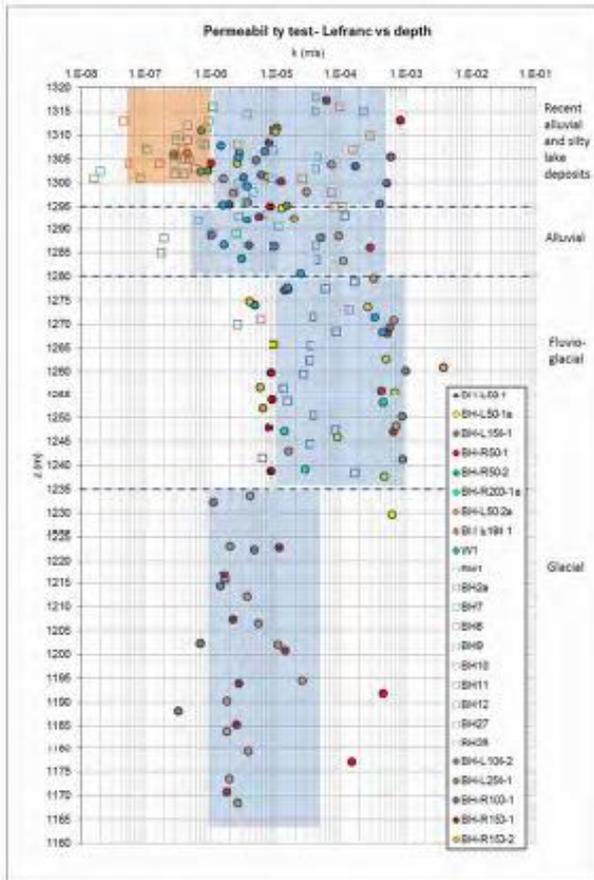
Figure 3 Permeability Data

The above permeabilities have been adopted by the EPC Designer based on the following, measured data (Figure 3):

Due to high variability in permeability in the alluvial and fluvio-glacial deposits, the IPOE recommended in its October 2016 report that the EPC Contractor undertake a sensitivity seepage analysis, i.e. vary the cut-off wall depth, permeability and ratio of K_h/K_v in the alluvial and fluvio-glacial deposits and their interface, in order to produce a seepage envelope that shows likely seepages vs cut-off wall depth for various scenarios.

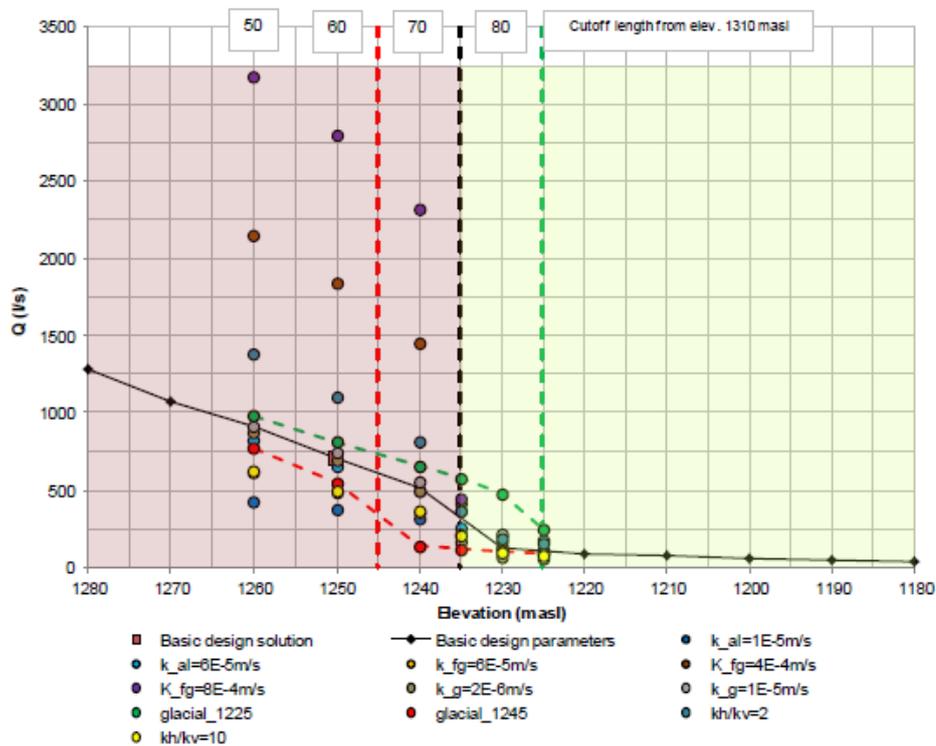
Figure 4 Seepage Sensitivity Results

Results of the seepage sensitivity analysis are presented in Figure 4 below. It can be seen that for an 85m deep cut-off wall a seepage of 170 l/s is expected, which is acceptable and is within the specified requirements.

The analysis has also shown that the maximum water table rise in the embankment would be 4m, which justifies a 5m thick drainage layer within the footprint of the embankment in the valley sections.

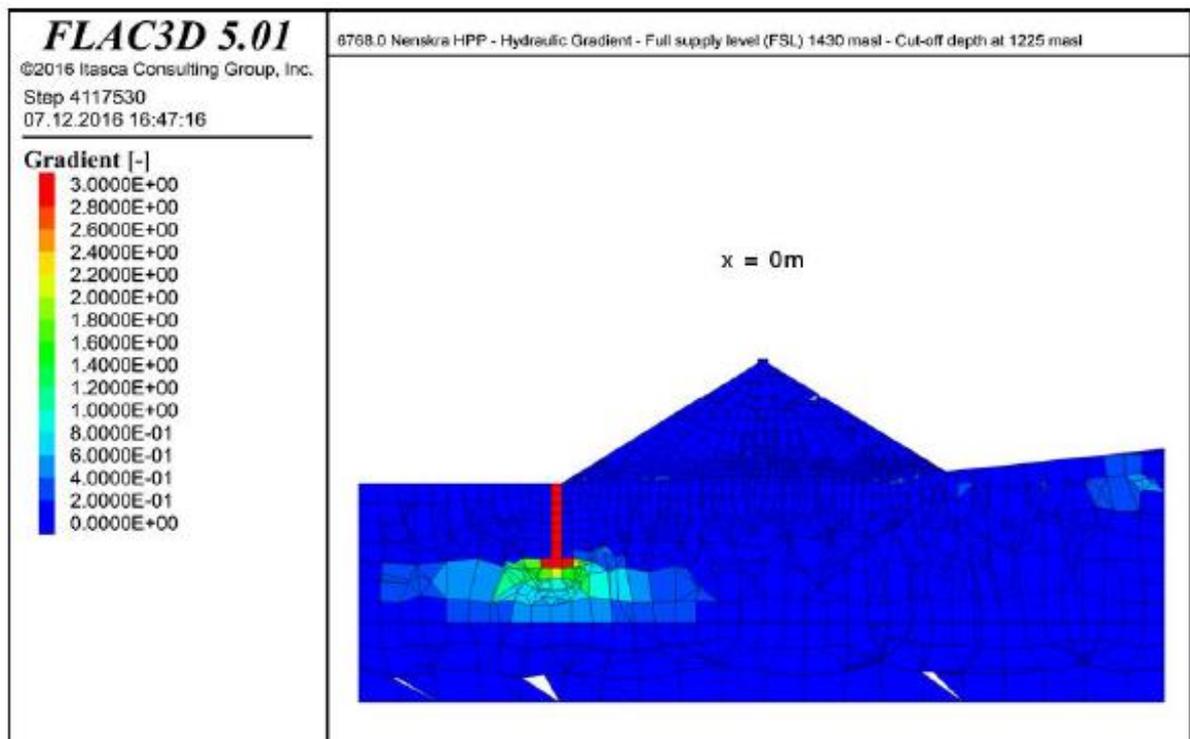
Figure 5 Hydraulic Gradient at the valley floor (cut-off wall depth at 1225masl)

The analysis has shown that the high gradients identified at the bottom of the cut-off wall are unlikely to lead to suffusion, due to confinement of the particles. Some local migration of particles might occur, but a presence of a thick filter layer, that would be placed between the foundation soil and the 3A embankment fill, over 80m length, should mitigate the risk that might be caused from the upwards movement of soil particles. The IPOE agrees with the analysis and conclusions.

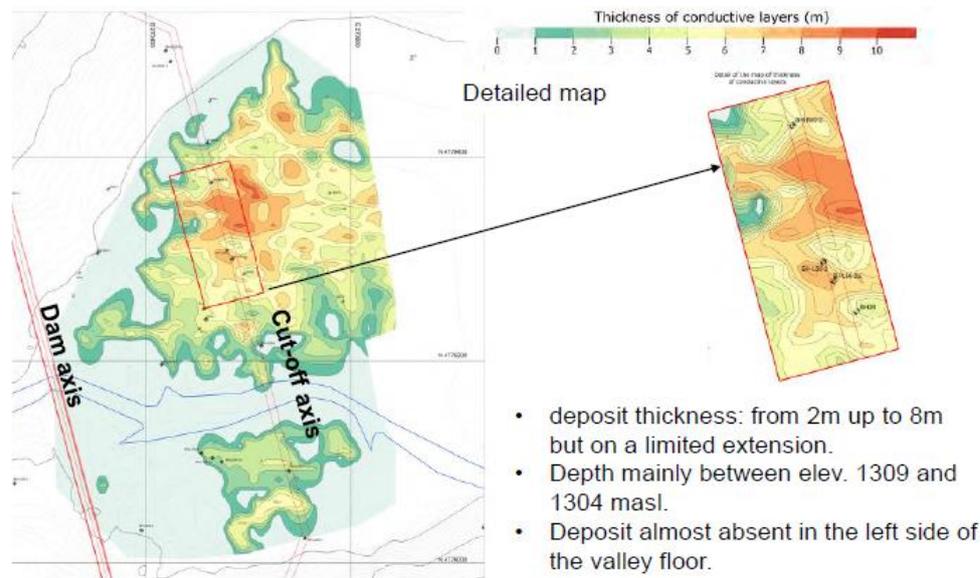
Figure 7 Location of Lacustrine Deposits

The design documents submitted in December 2016 show that soft lacustrine deposits, up to 10m thick, have recently been encountered in the valley floor, below the Zone 3A of the upstream embankment shoulder (see Figure 7 below). The artesian ground water table encountered in the deposits is +0.5m to –1m below the ground level.

These soft deposits were originally envisaged to be either excavated and replaced or treated in-situ. Since the ground water level is high, it is most likely that the deposits will not be excavated, but treated in-situ.

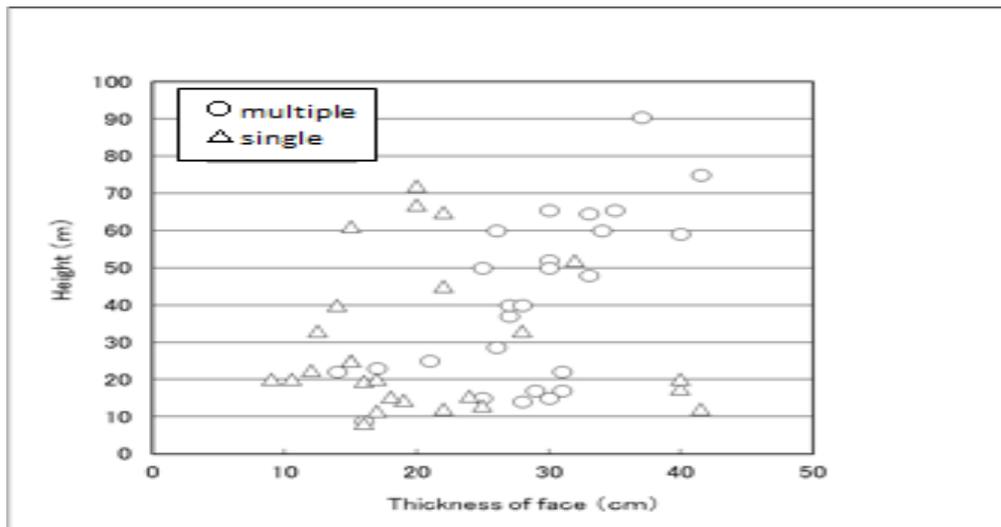
Figure 9 Height of AFRD and Thickness of Asphalt Face

As previously noted by the IPOE, Nenskra Dam is a very high AFRD, it will be subjected to large hydrostatic pressure and further consideration needs to be given to the appropriate thickness of the face. From past records of dam construction it can be noted that the thickness of the asphalt face increased as the height of the dam as well as the maximum water pressure. However, the thickness of the proposed Basic Design is uniformly 31 cm. Figure 9 below shows the thickness of the asphalt face vs the height of the current AFRDs.

The IPOE recommends that further consideration be given to the appropriate thickness of the asphalt face, which shall be determined by taking into consideration properties obtained from laboratory and field tests and the required performance.

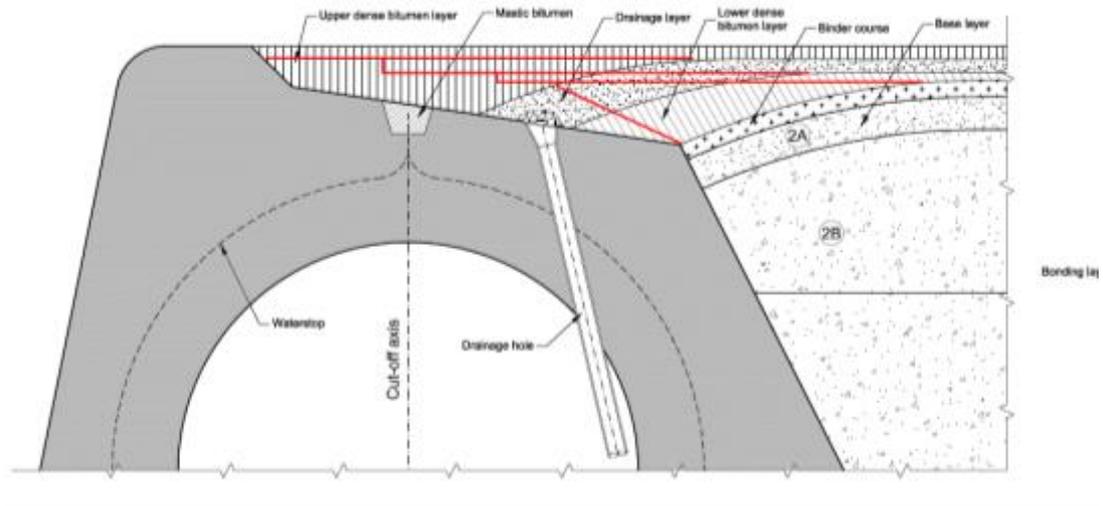
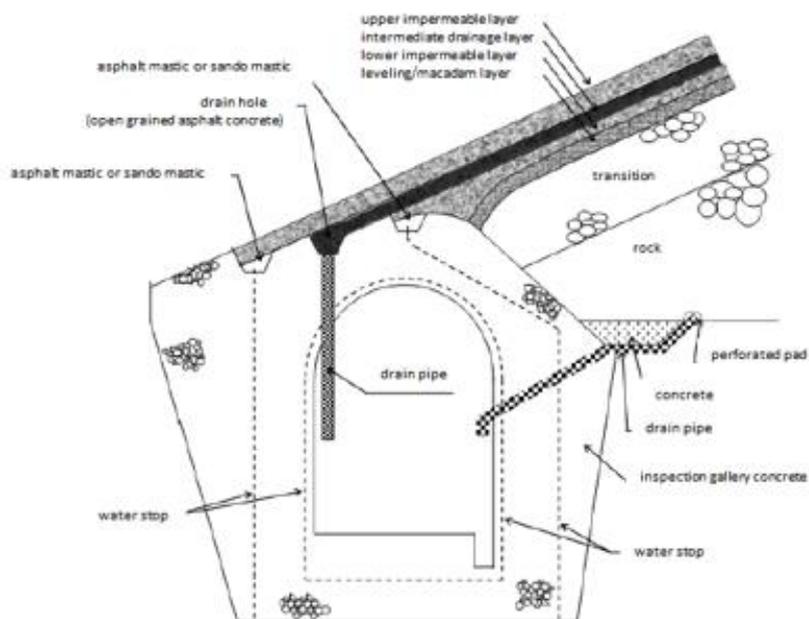
Regarding design of the joint part of the asphalt face and inspection gallery concrete, it seems difficult to pave the layers with asphalt finishers, since the thickness of each layer of the asphalt face is changing from place to place as shown in Figure 14. Therefore, the IPOE recommends that the connection part of the asphalt face with the gallery be designed as shown in Figure 15. The top of the gallery concrete should be a stepped shape, like stairs, so that the thickness of each layer can be uniform and straight. Paving work will be easier with asphalt finishers and achieve a higher quality result. The red lines in Figure 14 indicate an example of the modified shape of the top of the inspection gallery concrete and each layer of asphalt face.

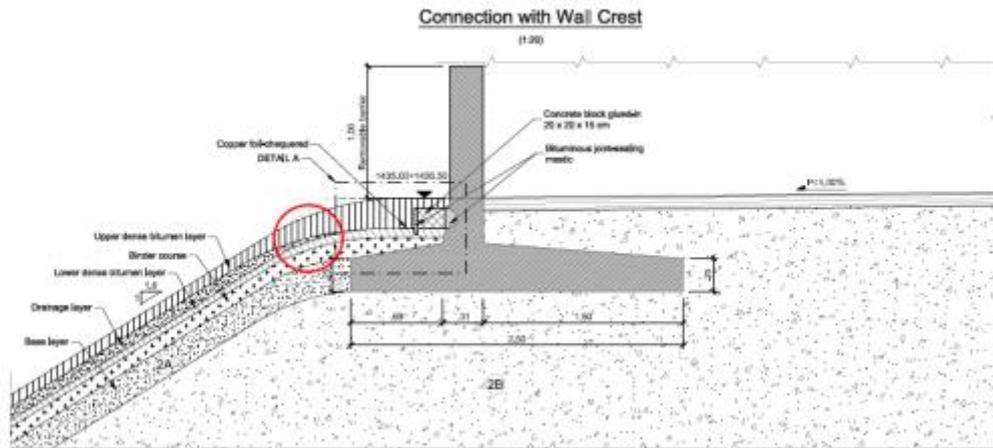
Figure 16 Asphalt Face at the Dam Crest

It seems difficult to pave the intermediate drainage layer near the crest, since it is gradually thinning as shown in Figure 16 below. The IPOE recommends that the shape of this part be modified in consideration of the construction stage.

The IPOE therefore recommends modifying the design of the face structure near the crest concrete in order to provide a larger flexibility against the displacement of the crest concrete during an earthquake.

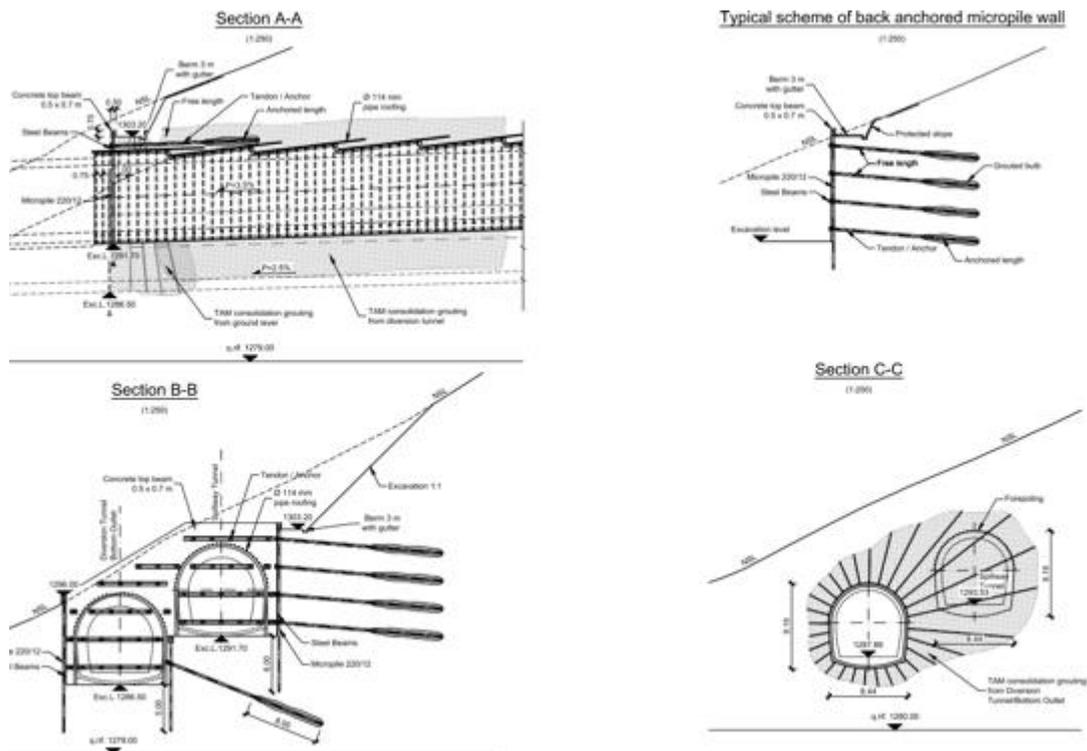
Figure 21 Downstream zone of the Bottom Outlet and Spillway Tunnel

As noted above the value of having a Bottom Outlet tunnel independent from the Spillway tunnel is a critical safety measure at Nenskra. It is important therefore for the two tunnels to be as independent from one another as practicable. The IPOE is concerned that the current arrangement of the two tunnels coming in close proximity at the downstream sections (Figure 21) limits this independence. Since the downstream sections are to be constructed in loose material should local movement arise due to earthquake or settlement then both tunnels are likely to be simultaneously affected. If the outlets of the two tunnels are separated this risk is reduced. Therefore the IPOE suggests further consideration of the alignment of the Spillway tunnel. This is discussed further at section 3.6.3.

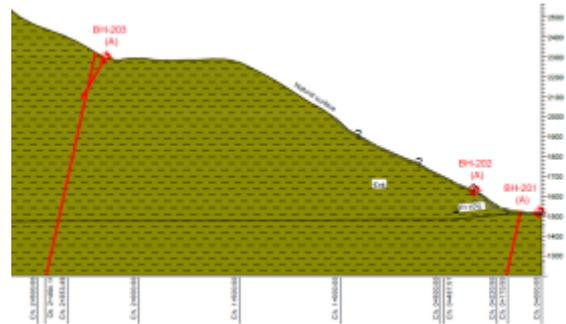
Figure 23 Section of the geological profile on former Transfer Tunnel alignment

Another comment concerns borehole BH-203 (Figure 23) planned to investigate a fault crossing the tunnel on the side of the Nakra Portal. The opinion of the IPOE is that taking account of the depth of the tunnel such a borehole - as it is drawn on the profile - may well give some useful information on the fault zone. However, in-depth extrapolation of this information over several hundreds of meters is extremely challenging in terms of position, as well as fabric and width, not to talk about hydrogeology. Since it will hardly be possible to drill it to the depth of the tunnel, and even less to be sure to touch the fault close to tunnel elevation. Such type of boreholes will not alleviate the need for investigations during excavation by means of drilling ahead of the TBM when approaching an expected or supposed fault zone.

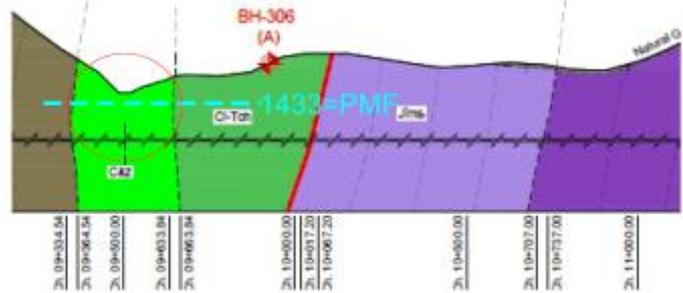
Figure 24 Section of the geological profile (L-6768-B-GL-HR-GE-DW-002_002, 15.12.16)

Concerning water losses in pressure tunnels, one "rule of thumb" (e.g. Talobre Rule in France) is that no special measures will have to be taken as long as the overburden is equal to the internal pressure expressed in meters of water head, and that the lateral distance to the slope is greater than 2.5 times this pressure. On the major part of the Headrace Tunnel alignment, these conditions are comfortably respected. The IPOE however draws attention to the section around chainage 09+500 (Figure 24) where the overburden, as well as the lateral distance to the slope, are both close to that "limit". Furthermore that section is close to a potentially permeable structure called "Frontal Thrust" on the geological map. It is strongly suggested to consider this zone for future borehole investigations. The results of such investigation could lead to a slight re-alignment, either by shifting the point where the tunnel changes direction further downstream or, if it then gets too close to the fault zone, by slightly changing the azimuth of the tunnel upstream of that point.

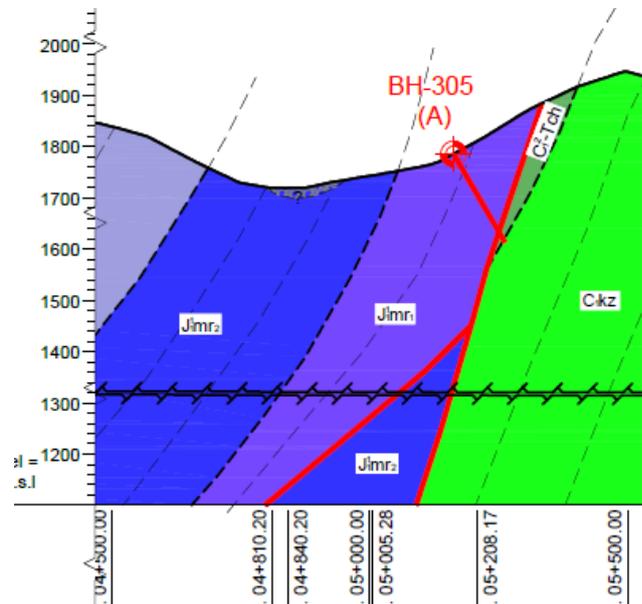
Figure 25 Section of the geological profile (L-6768-B-GL-HR-GE-DW-002_002, 15.12.16)

Regarding the future borehole investigations, as for the Transfer Tunnel mentioned above, the IPOE draws attention to the very limited information that can be obtained from "short" boreholes like those drawn on the geological section (even if they are 200-300 m deep), crossing a fault zone hundreds of meters above the tunnel. As already mentioned, in-depth extrapolation of that type of information is extremely challenging, especially where an expected fault zone is supposed to subdivide at depth (Figure 25).

Furthermore, such "superficial" investigation will hardly give any useful hydrogeological information. It is thus recommended to take account of that aspect for the location, direction and depth of the planned boreholes along the alignment of the Headrace Tunnel.
