Nenskra Hydropower Project

Supplementary Environmental & Social Studies

Volume 6 Natural Hazards & Dam Safety

November 2017

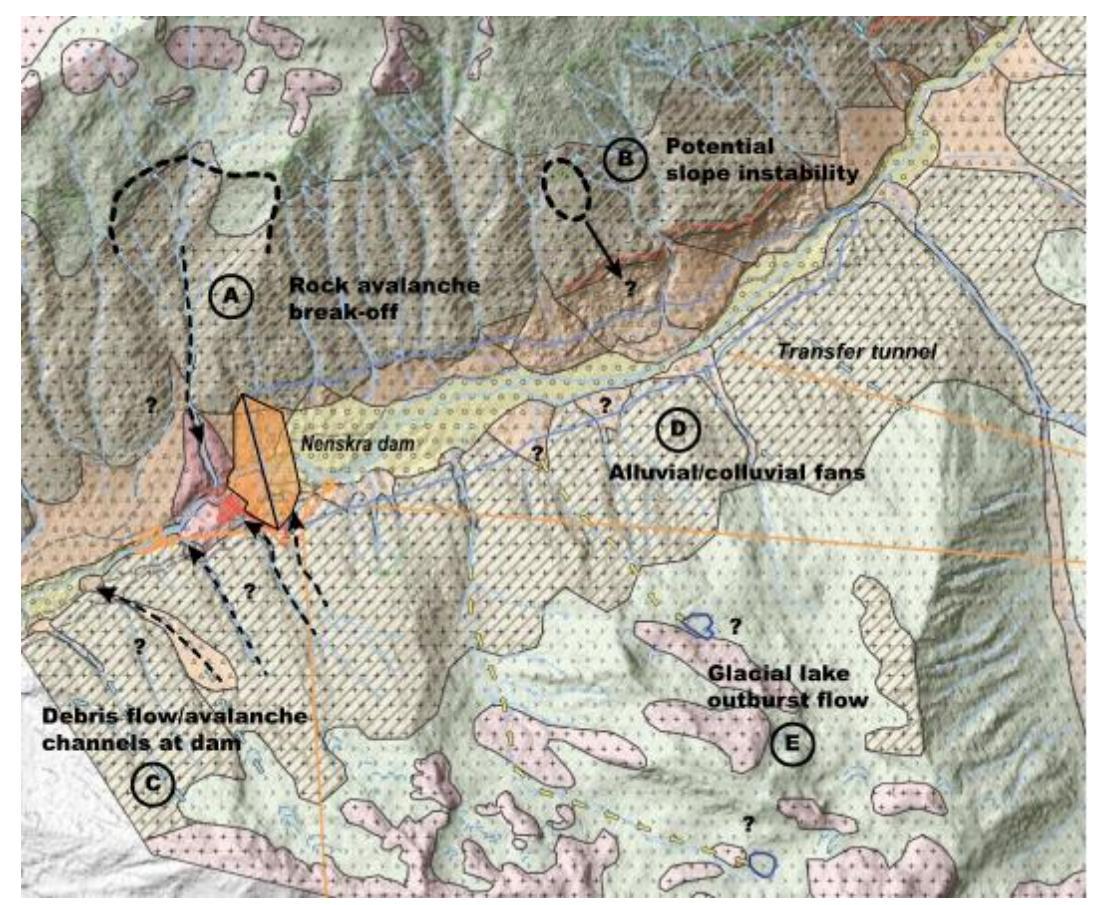
Figure 3 – Geomorphology of the Nenskra reservoir – indicating major hazards

The Nenskra dam and reservoir are exposed to a number of natural hazards as illustrated by the map below and described in the following subsections.

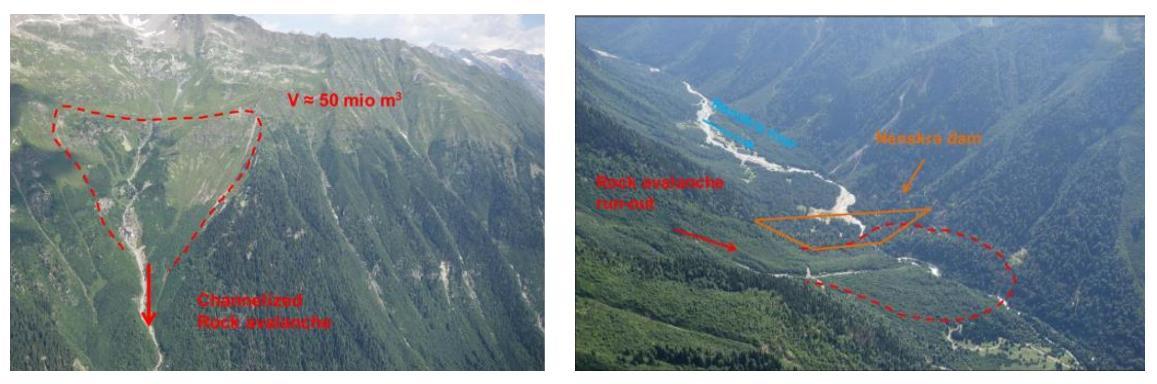
Figure 4 – Historical evidence of landslide at the dam site

Visual evidence of an historical landslide deposit at the dam emplacement. Left: View from the left bank towards the detachment zone of the landslide event. The volume of the material is probably significantly less than 50 million cubic metres. Right: Maximum extension of the landslide and run-up area on the opposite slope.

Although the possibility of landslide is low, the stability of the slope will be monitored. If the monitoring identifies a risk of landslip the reservoir water level will be lowered as a measure to reduce the likelihood of potential dam failure (see section 5.1 - Table 9 - safeguards for initiating event 2).

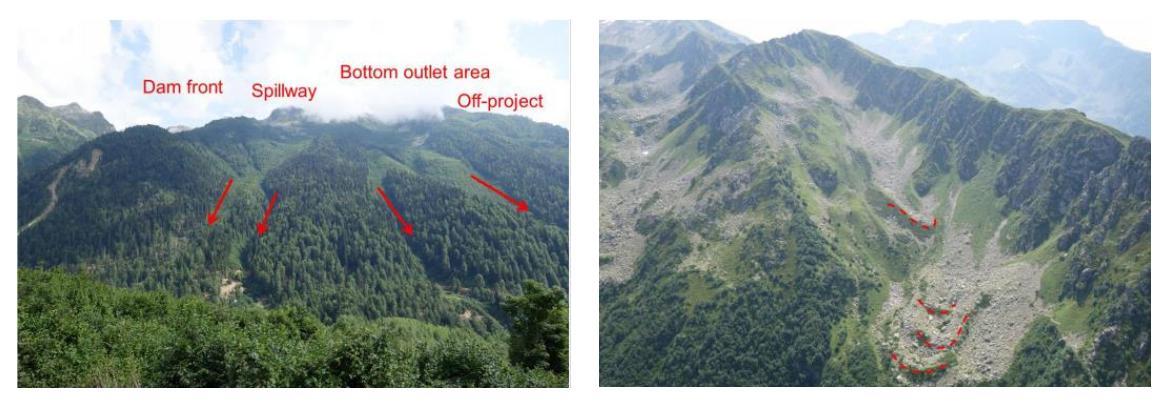
Figure 5 – Debris flow/avalanche channels in the area of the dam

On the left bank (see Figure 3). There are 3 alluvial/debris channels which align (i) with the upstream dam face in the left abutment, (ii) the downstream dam face or spillway area and (iii) the Bottom outlet tunnel portal area. A forth channel probably points downstream of the project area (Figure 5).

Debris flow/avalanche channels on the left slope above the dam (left) and uphill area of the rightmost channel (right).

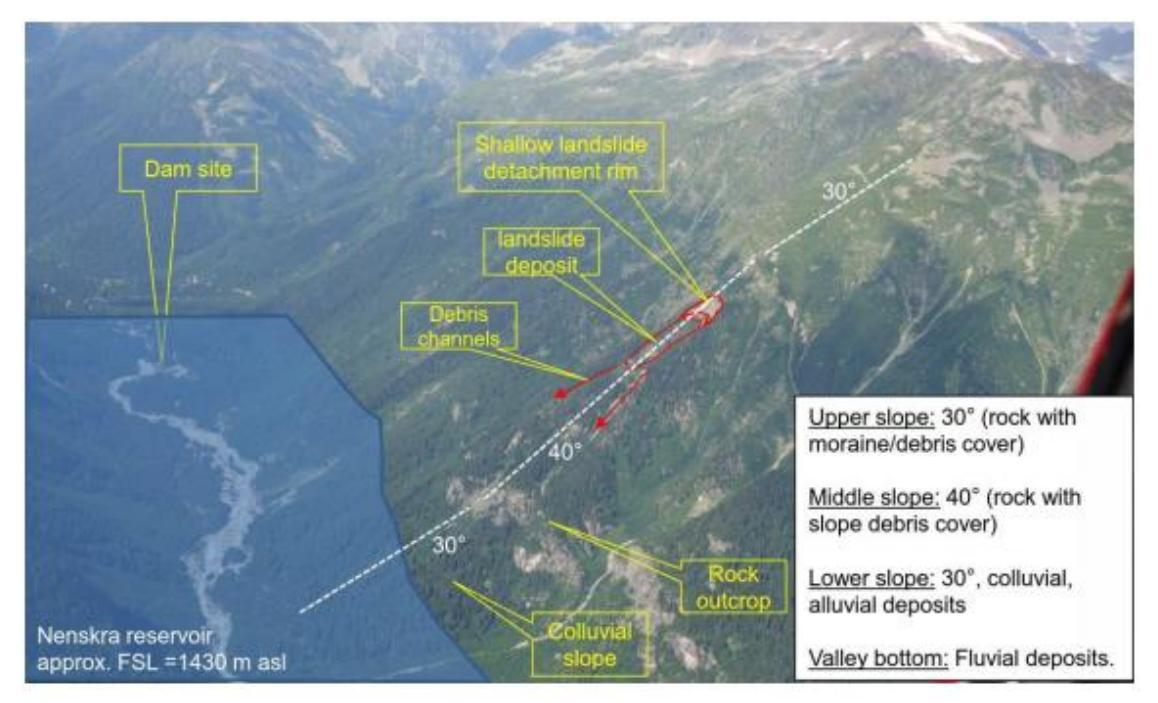
Figure 6 – Aerial view of the area of uncertain slope stability

- The lower, forested part is steeper (40 degrees) and is composed of bedrock with a variable soil cover made of a mix of glacial deposits and slope debris.
- The upper, grass covered part is less inclined (30 degrees), its substratum is composed of sub-outcropping bedrock with a thinner soil cover principally made of glacial deposits and pre-glacial erosion remnants.

A summary of the assessment of the slope stability is provided in Annex 5. The overall conclusion is that there is no evidence to suggest the possibility of general, larger-scaled slope instability. The volume of the unstable material is significantly smaller (by a factor of at least 15,000) than the volume of the reservoir. Two possible slope instability scenarios have been studied to evaluate the consequences of a small superficial landslide on the reservoir and dam:

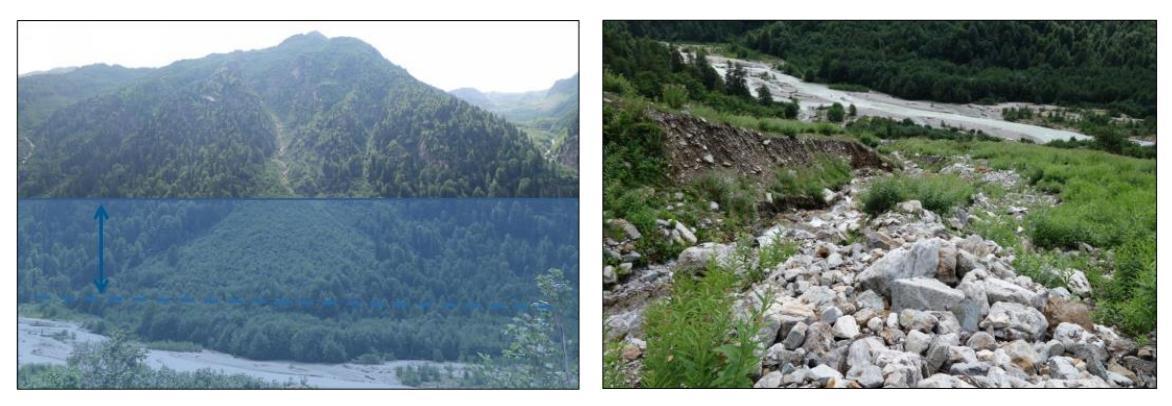
Figure 7 – Submerged alluvial/colluvial fans

Typical situation of a alluvial/colluvial fan which will be submerged by the reservoir and subject to reservoir drawdown (left) and soil structure of such a fan, composed of large-scale granular material (cobbles to blocks) in a sandygravelly matrix (right).

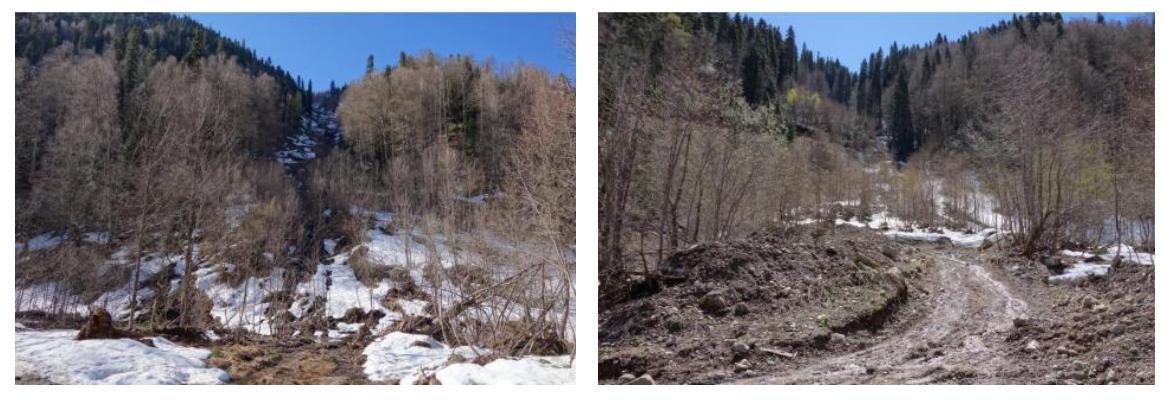
Alluvial/debris fans with possible debris flow and snow avalanche activity which point towards the upstream face of the dam (left) and the initial and middle/final part of the surface spillway (right). Figure 9 – Reservoir spillway – and avalanche and debris flow channels

The reservoir spillway will be a tunnel spillway. It is well protected against surface processes such as avalanches, debris flows and spontaneous earthquake-triggered soil slides, but is vulnerable to clogging from floating debris. However, the spillway inlet is a risk of blocking from avalanche and debris flow events and protection measures will be included in the design.

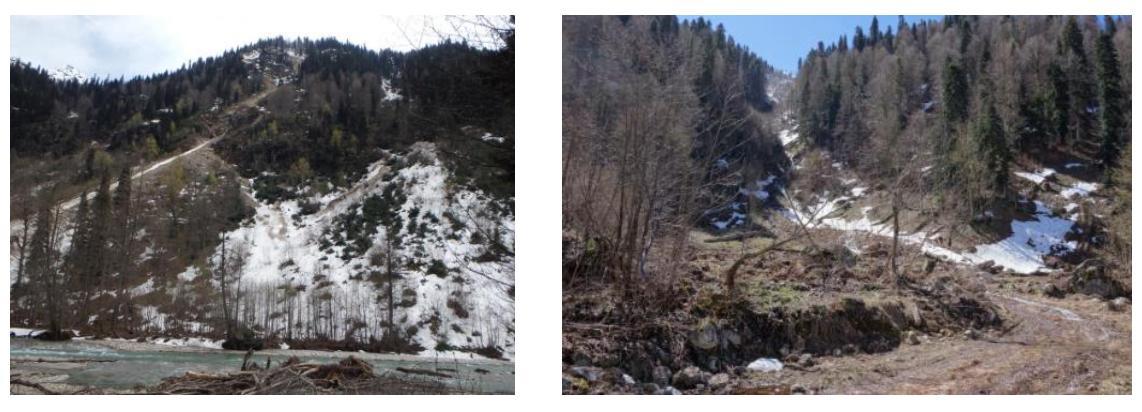
Figure 11 – Bottom outlet inlet and outlet portals

The Bottom Outlet's inlet and outlet portals are both situated in areas potentially affected by alluvial/debris fans with possible debris flow and avalanche activity. The inlet portal in particular is at risk of clogging due to floating debris (heavy rainfall, avalanches) and debris flow material. The design of the structures will take account of these possible hazards as the bottom outlet is a safety feature allowing the reservoir water level to be lowered if a safety issue arises, and blocking the bottom outlet would also stop the ecological flow leading (to environmental consequences).

The intake portal of the Bottom outlet tunnel is located at the foot of the snow-covered debris fan on the right of the photograph (left). The alluvial/debris fan with snow avalanche activity which points towards the area of the exit portal of the Bottom outlet tunnel (right).

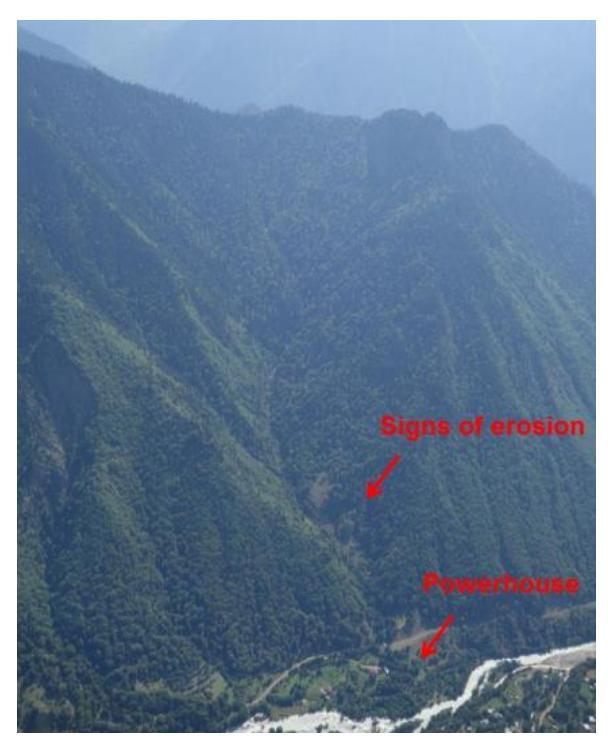
Figure 12 – Aerial view of the powerhouse area and smaller valley above

A preliminary analysis of the geological, geomorphological and topographic situation shows that there may be possible sediment transport/debris flows during periods of heavy rainfall along the lateral torrent and at the exit of the upstream valley.

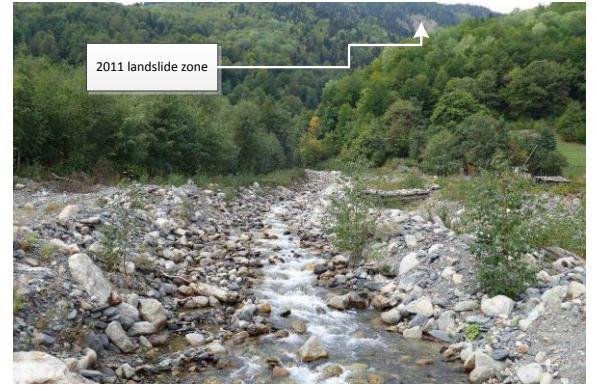
Lekverari torrent Photo taken from Nakra village. 2011 landslide visible in upstream gorge

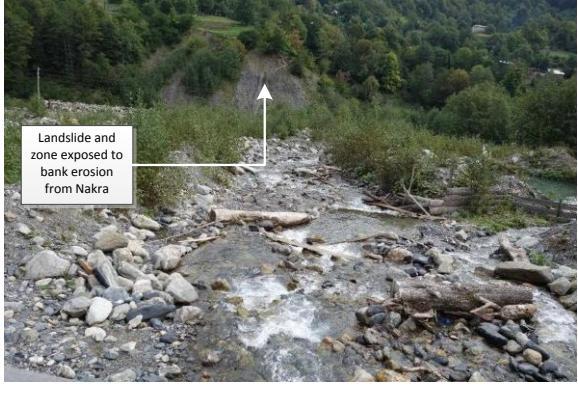
Lekverari torrent at Nakra village – looking downstream to the confluence with Nakra

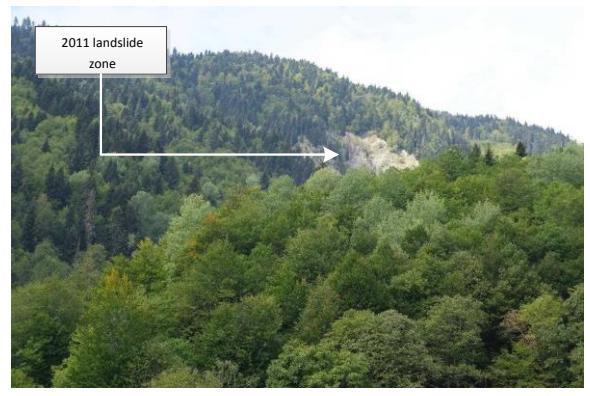
Lekverari gorge - zone exposed to landslide risk

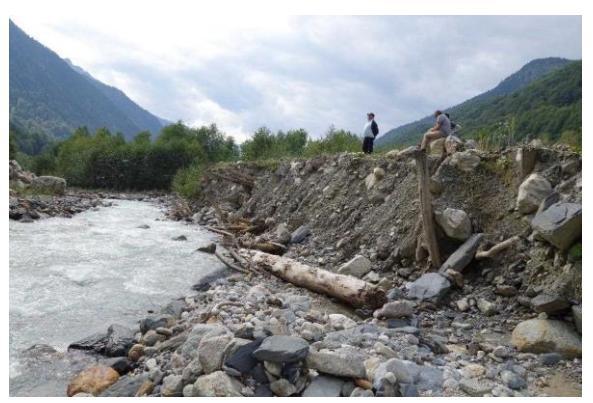
Nakr River – at Nakra village – remains of solid material transported by Lekverari torrrent followin g landslide in 2011 – and which blocked the Nakra Illustrates the depth of material that blocked the river

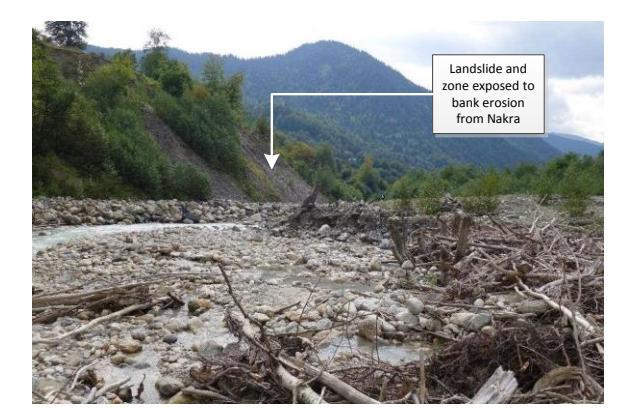
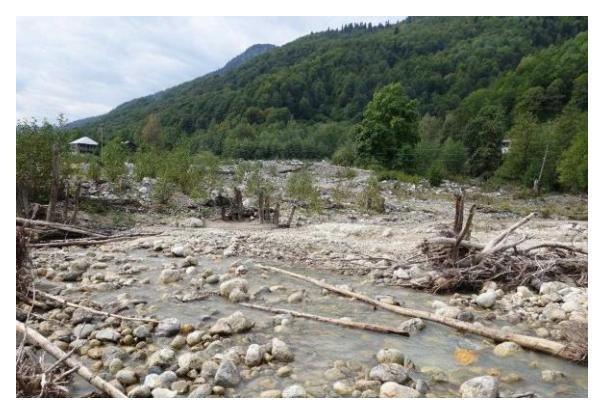
Lekverari torrent aluvial fan at confluence with Nakra River
