NENSKRA HYDROPOWER PROJECT, GEORGIA

Fish, Invertebrates and Otter Monitoring

Surveys N1

Final report

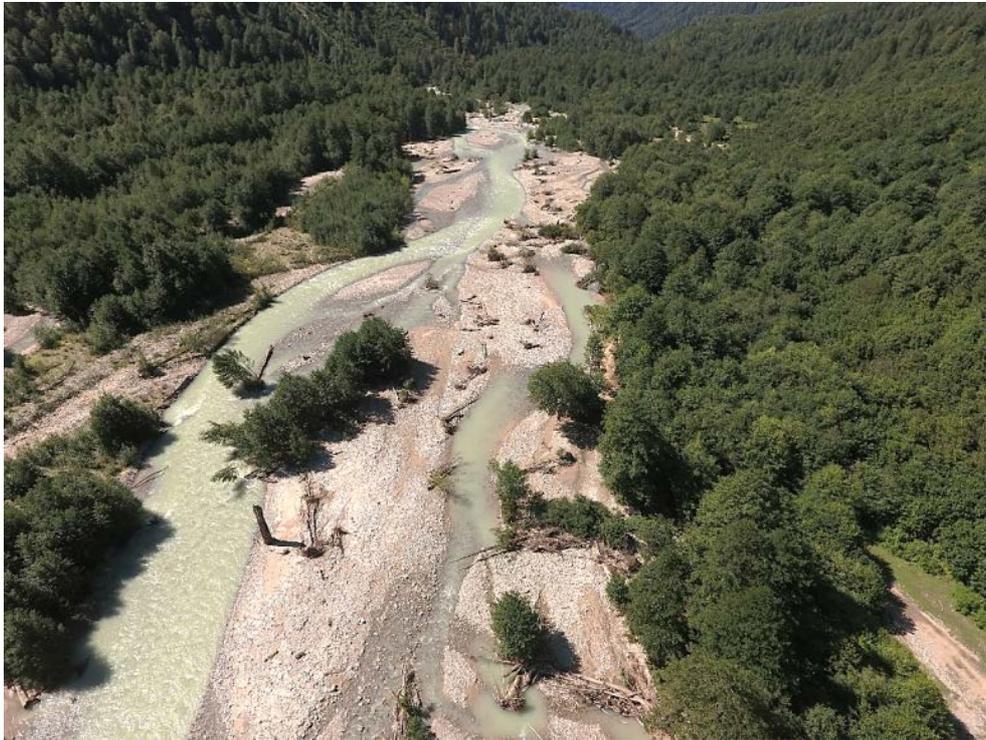
Figure 4. Monitoring station 1 (Nenskra river, 06.09.2017)

- It is located 24 km upstream confluence with Enguri and 18 km from the source. The catchment area - 200 km², the elevation - 1380 m. The form of valley is U-shape (Figure 4).
- The channel type is classified as braided. Bed elements - bars, islands, and riffles.
- Flow types included chaotic and broken standing waves.
- The right and the left banks are steep, both forested with trees and bushes.
- Islands are divided river into two main and few temporary arms. The average width of the main arms was 13 m, and varied from 10 to 21 m. The average width of the temporary arms was 10 m, and varied from 7 to 12 m.
- The riverbed covered mainly by cobble (39%), pebble (20%) and sand (20%).

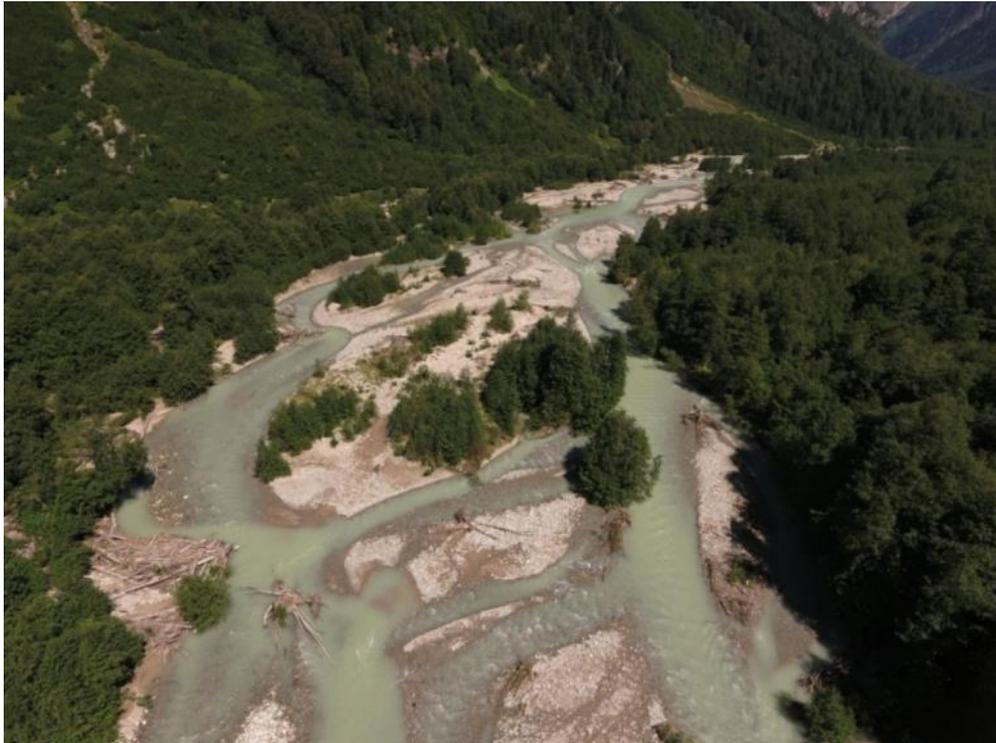
Figure 5. Monitoring station 2, (Nenskra river, 05.09.2017)

- It is located 22.5 km upstream confluence with Enguri and 19.5 km from the source. The catchment area is 215 km². The elevation is 1337 m. The form of the valley is U-shape (Figure 5).
- The channel type classified as a braided.
- Bed elements included bars, islands, and riffles.
- Flow types included broken standing waves and unbroken standing waves.
- The left bank is flat; right bank is steep. Both banks are forested with tree and bushes.
- Islands are divided river into two main and few temporary arms. The average width of the main arms was 18 m, and varied from 10 to 27 m. The average width of the temporary arms was 12 m, and varied from 10 to 17 m.
- The riverbed covered mainly by cobble (41%) and pebble (25%).

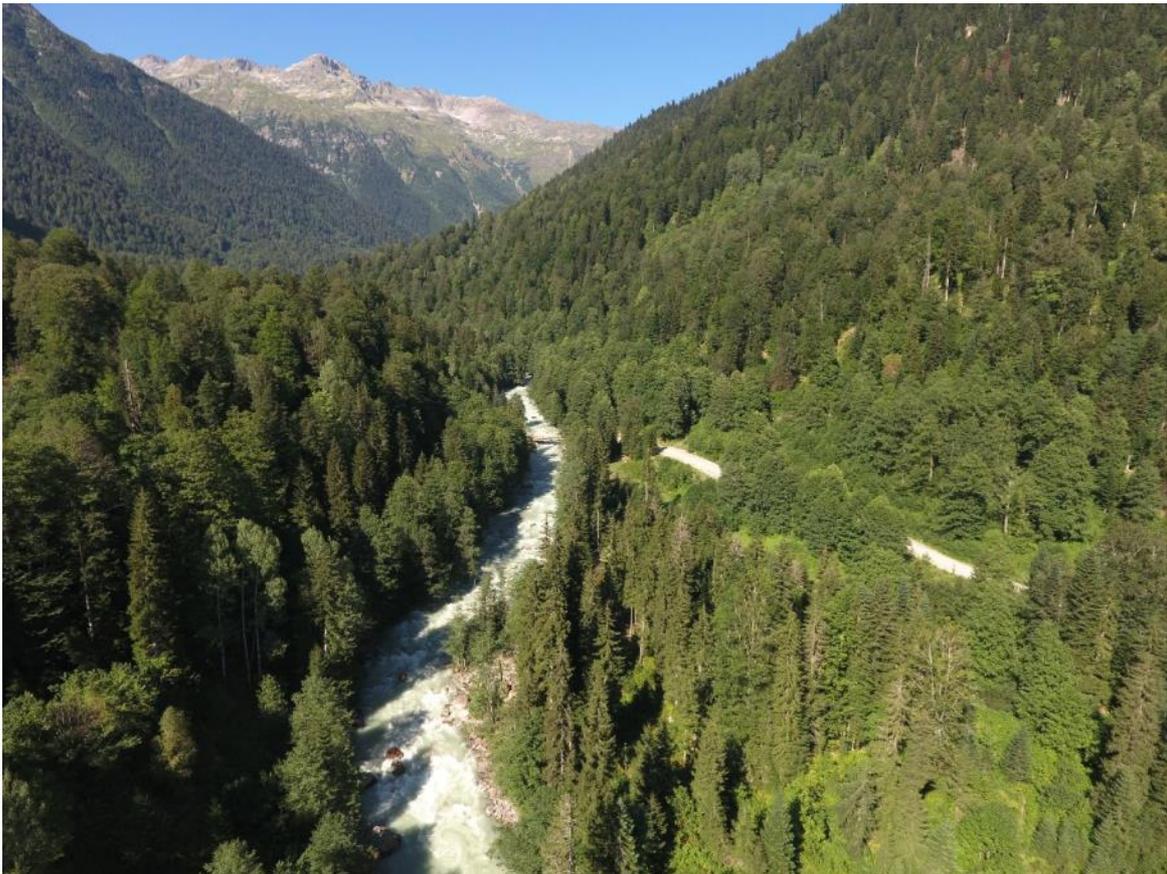
Figure 6. Monitoring station 3 (Nenskra river, 05.09.2017)

- It is located 19 km upstream confluence with Enguri and 23 km from the source. The catchment area is 220 km². The elevation is 1260 m. The form of the valley is V-shape (Figure 6).
- The channel type classified as a single.
- Bed elements included rapids, rocks and step pool.
- Flow types included chaotic and broken standing waves.
- Both banks are steep and forested with trees.
- The average width of the river was 16 m, and varied from 10 to 22 m.
- The riverbed covered mainly by cobble (56%) and pebble (23%).

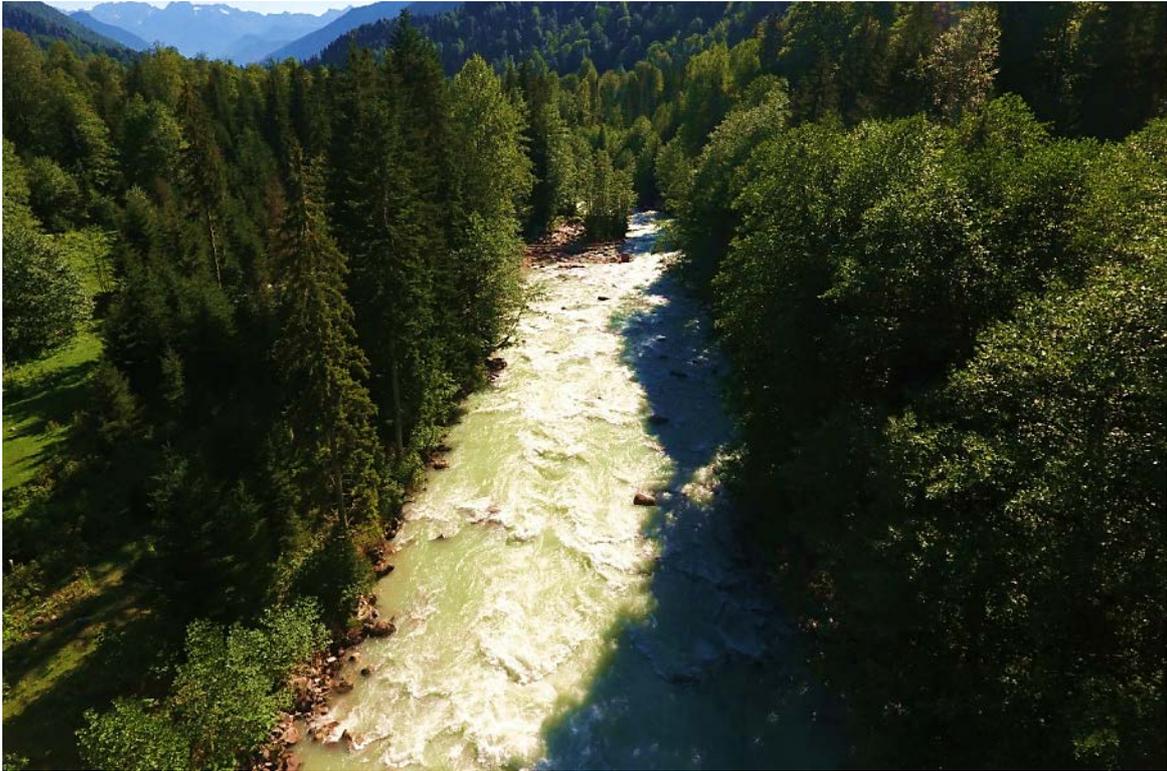
Figure 7. Monitoring station 4 (Nenskra river, 05.09.2017)

- It is located 15.8 km upstream confluence with Enguri and 26.2 km from the source. The catchment area is 290 km². The elevation is 1136 m. The form of the valley is V-shape (Figure 7).
- At the right bank, there is an automatic hydrological station setup by JSNCH with hydrometric rod for water level measurements located (Figure 8).

- The channel type is classified as a single.
- Bed elements included riffles, rapids and rocks.

- Flow types included chaotic, broken and unbroken standing waves.
- Both banks are steep and forested with trees.
- The average width of the river was 15 m, and varied from 12 to 18 m.
- The riverbed covered mainly by cobble (51%) and pebble (26%).

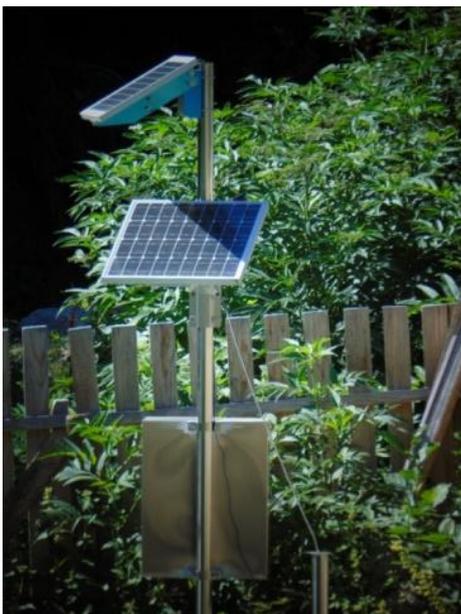
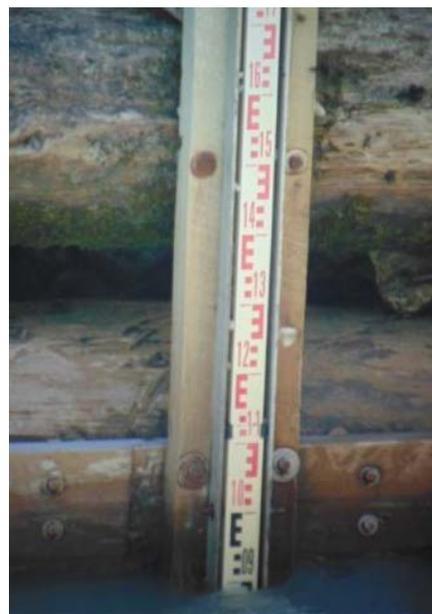
Figure 8. Automatic hydrological station (Nenskra river)

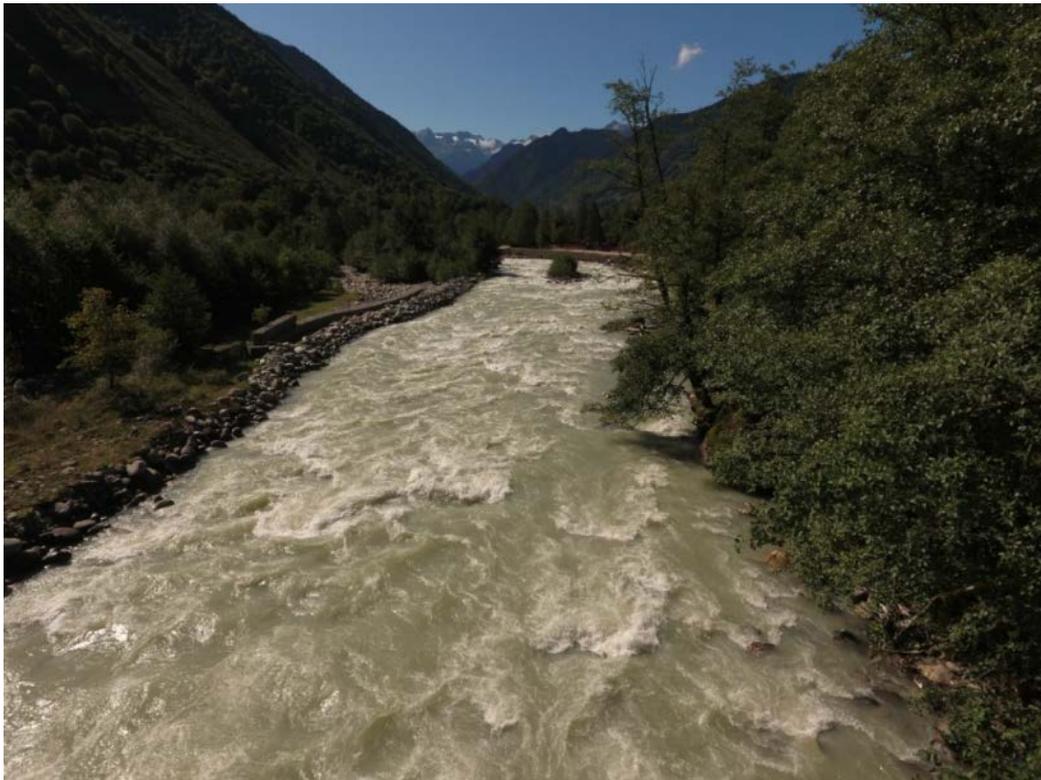
Figure 9. Monitoring station 5 (Nenskra river, 08.09.2017)

- It is located 5.6 km upstream confluence with Enguri and 36.4 km from the source. The catchment area is 390 km². The elevation is 782 m. The form of the valley is U-shape (Figure 9).
- The channel type is classified as a single.
- Bed elements included rapids and riffles.
- Flow types included broken and unbroken standing waves.
- The right bank is flat; left bank is steep. Both banks are forested with trees. Some bank protections are made of gabions.
- The average width of the river was 20 m, and varied from 18 to 26 m.
- The riverbed covered mainly by pebble (35%) and gravel (26%).

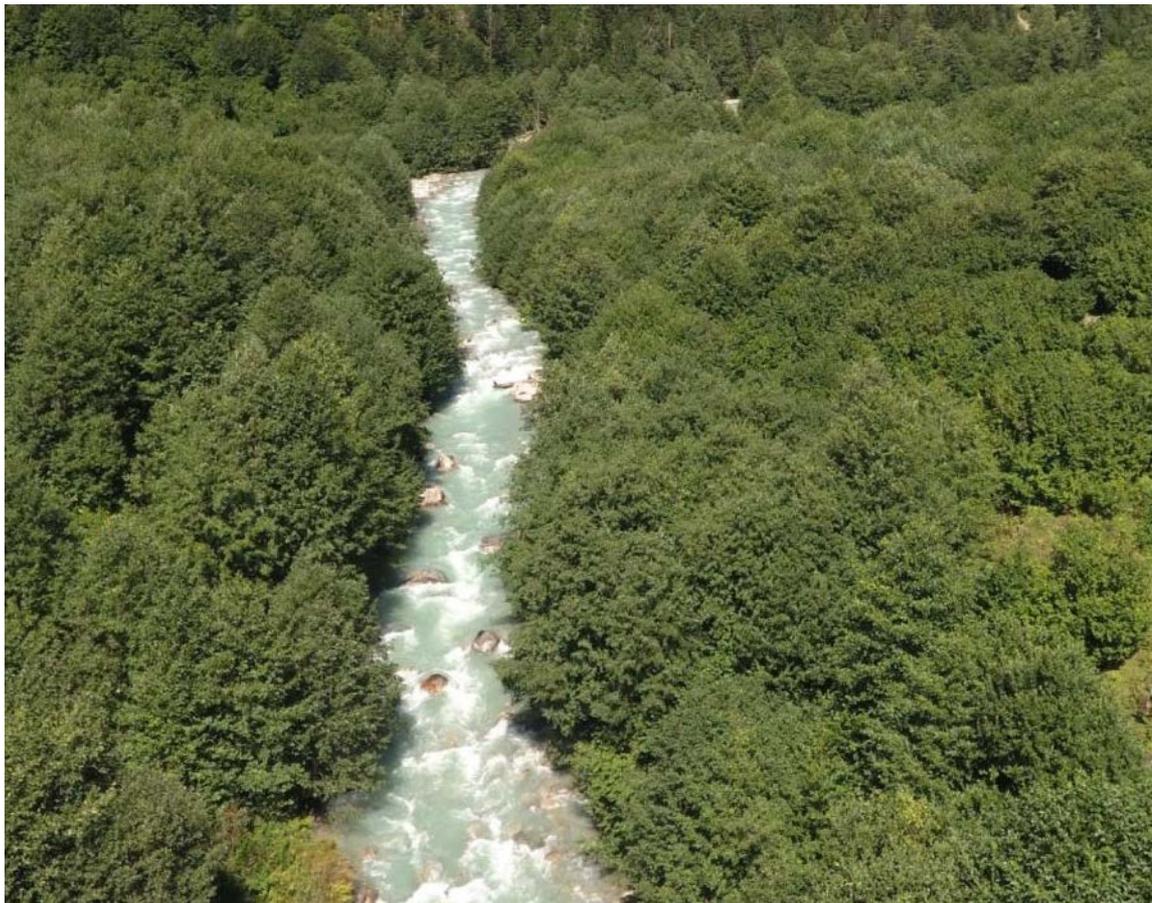
Figure 10. Monitoring station 7 (Nakra river, 09.09.2017)

- It is located 10.3 km upstream confluence with Enguri and 11.7 km from the source. The catchment area is 87 km². The elevation is 1590 m. The form of the valley is U-shape (Figure 10).
- The channel type is classified as a single.
- Bed elements included bars and riffles.
- Flow types included chaotic and broken standing waves.
- The right is flat and the left bank is steep. Both banks are forested with trees.
- The average width of the river was 10 m, and varied from 7 to 15 m.
- The riverbed covered mainly by pebble (47%) and gravel (23%).

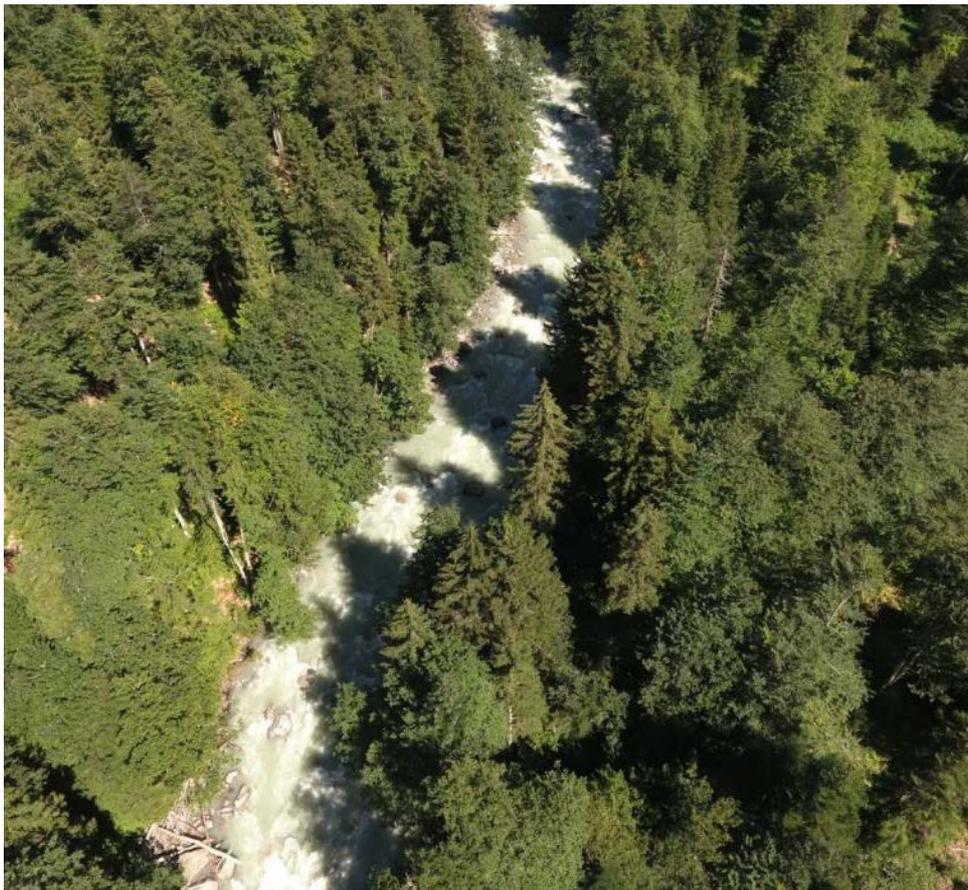
Figure 11. Monitoring station 8 (Nakra river, 09.09.2017)

- It is located 9.2 km upstream confluence with Enguri and 12.8 km from the source. The catchment area is 100 km². The elevation is 1520 m. The form of the valley is V-shape (Figure 11).
- The channel type is classified as a single.
- Bed elements included rapids, rocks and step pool.
- Flow types included chaotic, broken and unbroken standing waves.
- Both banks are steep and forested with trees.
- The average width of the river was 12 m, and varied from 10 to 18 m.
- The riverbed covered mainly by gravel (38%), cobble (29%) and pebble (25%).

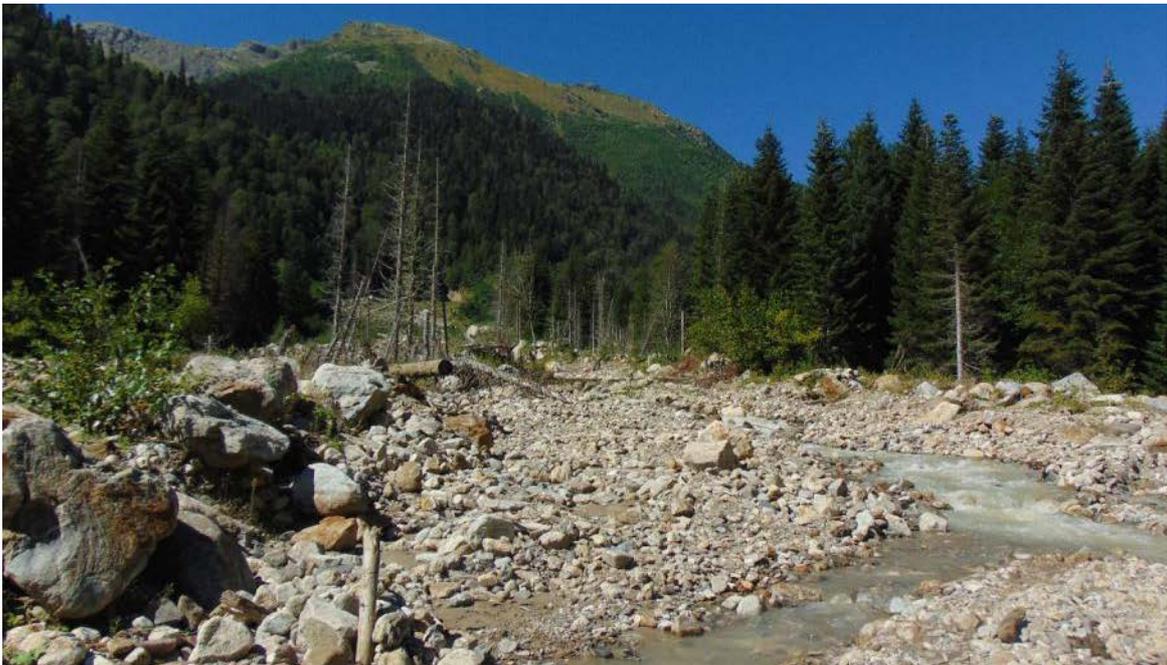
At both rivers, there are locations, where powerful natural landslide appears with significant consequences. In 2011, such a natural landslide occurred at Lekverari River and transported a significant amount of sediment downstream to the confluence with the Nakra River, and blocked the Nakra by creating a natural dam. One can see its consequences till now (Figure 13).

Figure 13. Landslide on Lekverari river (Nakra river basin)

There are consequences of the naturally occurring landslides visible at both rivers. In conditions of low flow, the capacity of the rivers (both Nenskra and Nakra) to move stones is reduced. Without high flow events, landslides could lead to establishment of natural unpassable barriers for the trout upstream migration.

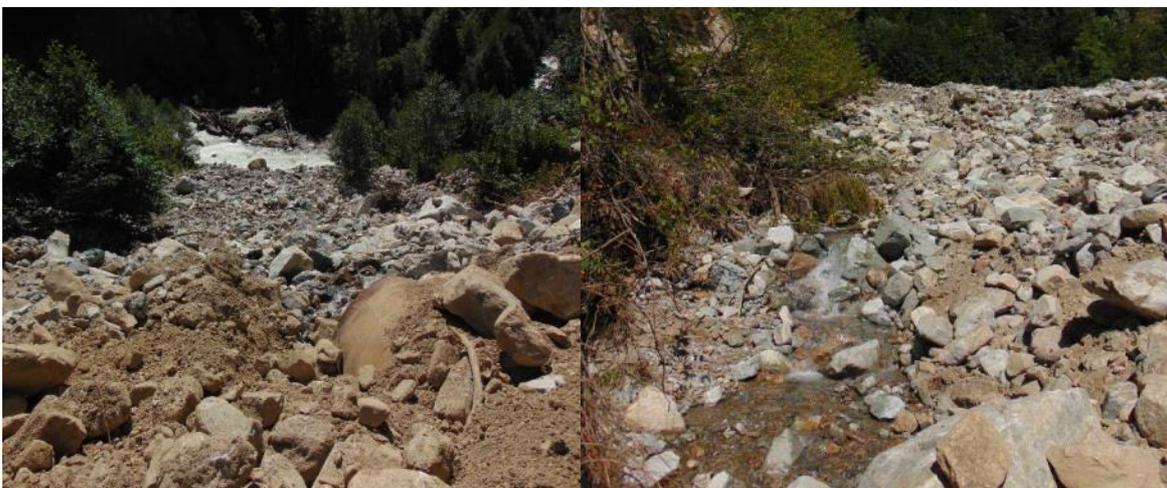
In Nenskra basin, its right-side tributary upstream Tita village also brings a significant amount of sediments and transports them downstream, to the confluence with Nenskra (Figure 14.) In conditions of natural flow, both rivers can move the jams, created by the naturally occurring landslides.

Figure 14. Landslide (Nenskra river basin)

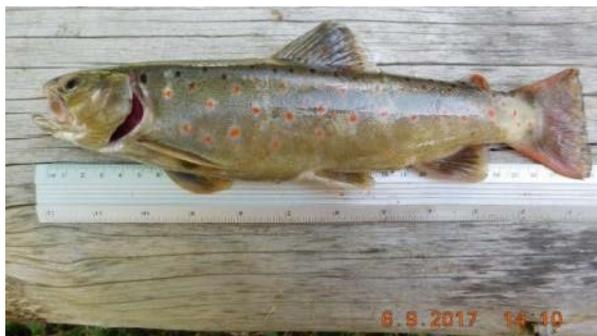
Figure 20. The biggest specimen of brown trout caught in Nenskra

Fish composition and abundance was studied using casting net, ichthyologic net and fishing røde. During the surveys, in total 47 fish specimens were caught at 8 monitoring stations. They belong to two species. 46 fish specimens were identified as *Salmo trutta*, out of these, 34 in Nenskra and 11 in Nakra. The biggest number of caught brown trout was in the place of the proposed impoundment structures at Nenskra, monitoring station 2. The sizes of brown trout caught varied from 7 to 25 cm, in Nakra from 9.5 to 14.5 cm (Figure 20).

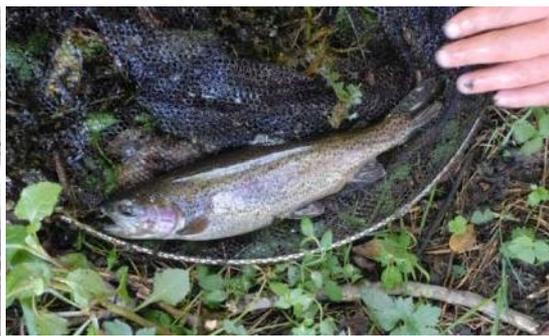
Figure 21. The only specimen of *Oncorhynchus mykiss*

The only specimen of rainbow trout (*Oncorhynchus mykiss*) was caught by ichthyologic net in the village Zemo Marghi (Lari Lari) (Figure 21). Most probably it had escaped from the private trout farm located in the pond upstream construction camp.

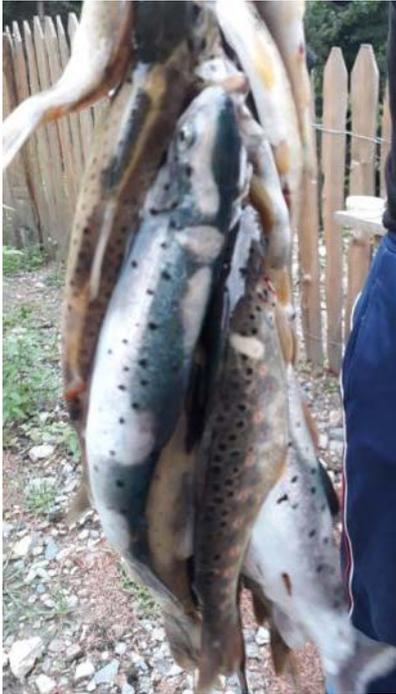
Figure 22. Specimen of potential Black Sea salmon, caught by locals

In addition to site survey, the Consultant also interviewed local fishermen. During the interviews, it was understood that sometimes in the river, the fishermen can catch a large (up to 9 kg) fish. The species cannot be clearly determined, but by description the most similar species would appear to be the Black Sea salmon (local name is “oraguli”). The Consultant obtained photo of the two caught specimens in Nenskra in September 2017 (Figure 22). But at present it is impossible to identify the species.

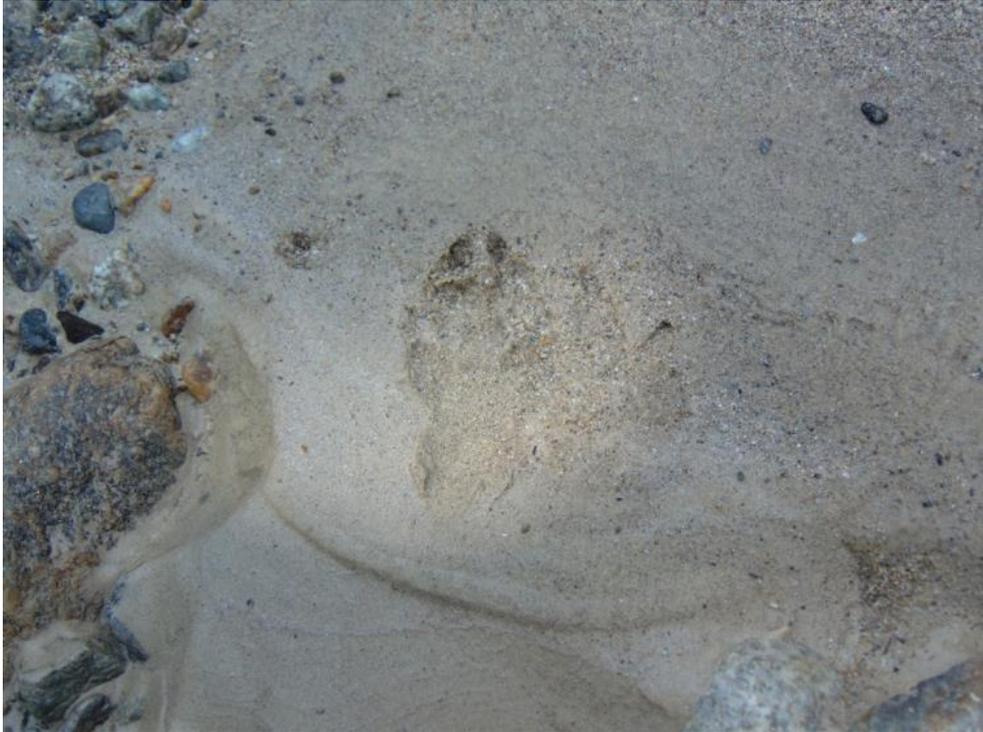
Figure 27. Traces of hind legs of otter found at Nenskra

At Nenskra, upstream the future impoundment structure, the Consultant found unclear traces of young otter with typical "heel" (Figure 27).

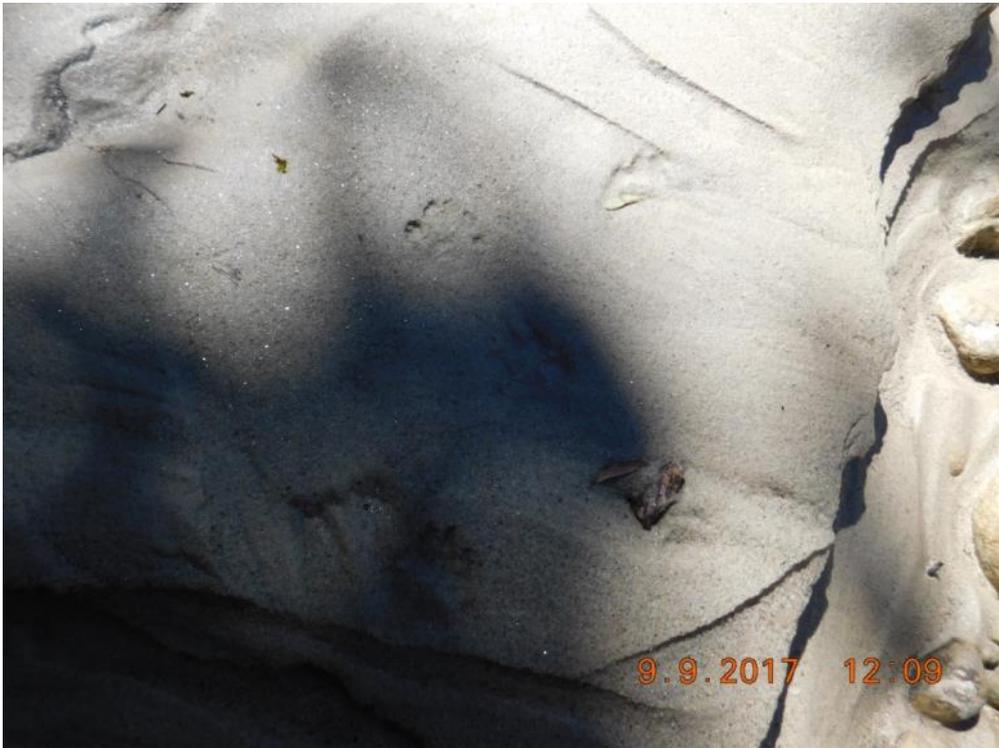
Figure 29. Traces of otter at Nakra

According to the owner of the pond with carps at Nakra, no traces of otter as well as less fish were fixed. However, during the detailed study of photos made in the upper Nakra, the Consultant found quite clear trace of foreleg of otter (Figure 29), which differ from present dog traces (at photo in shadow of the tree) by presence of five fingers. The trace of hind leg is also identifiable by five fingers, although the “heel” is outside of sand and there is no trace (down at the photo in the shadow).

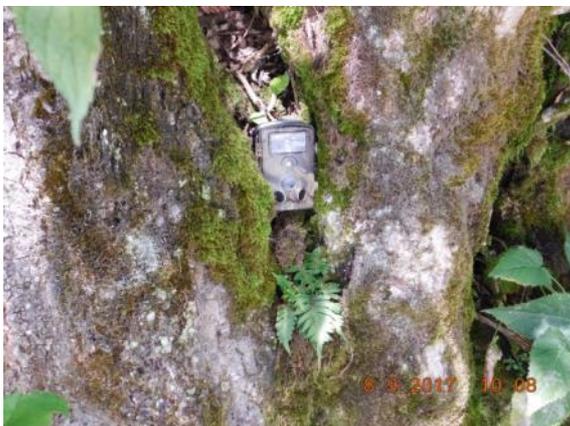
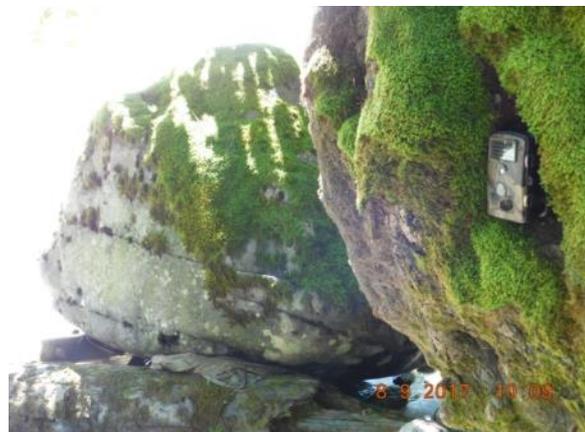
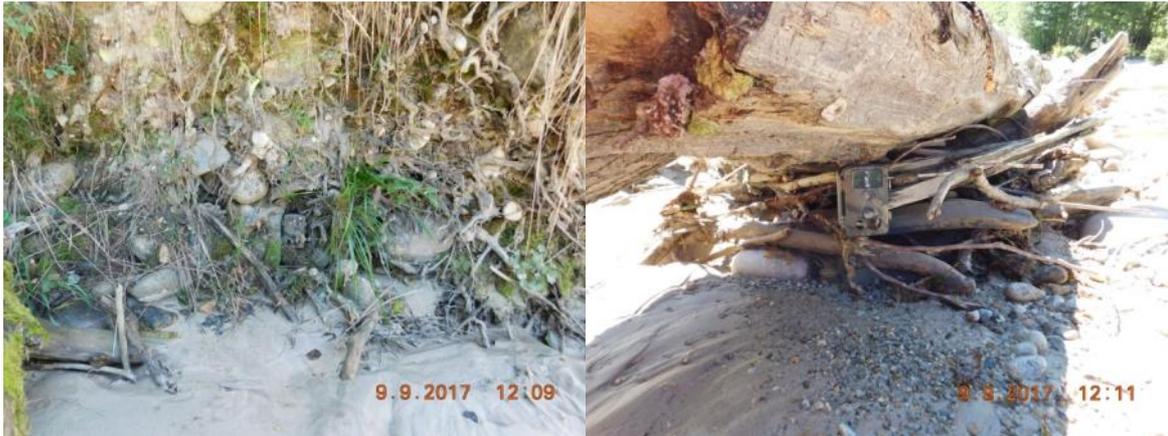
Figure 30. Habitats where cameras LTL ACORN 5225BR Long Range were placed

In order to fix the otter presence, the Consultant used the method of infrared photo fixation using cameras LTL ACORN 5225BR Long Range. The cameras were placed near the trace at Nenskra as well as in five additional suitable habitats (Figure 30). Near the trace, the Consultant placed bait (fish). During the surveys, none of cameras fixed the otter presence.
