International Panel of Experts

Safety of Nenskra Hydropower Project - Georgia

STAGE II REPORT - Part 2 & Final

Date: 27 February 2017

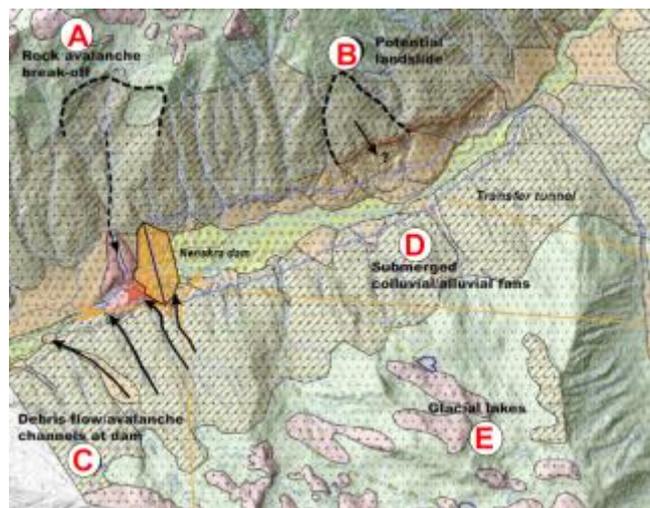
IPOE notes that attention is drawn to 5 zones/types of natural hazards within the extension from the Dam to the upper end of the reservoir, namely a "channelized rock avalanche" (A) which points to the alluvial fan immediately downstream of the Dam for which it is most likely responsible, the already mentioned Right Bank "Potential Landslide" (B) in the upper half of the reservoir, "Debris flow/avalanche channels" (C), "Submerged colluvial-alluvial fans" (D) and "Glacial Lakes" (E).

Concerning "Rock Avalanche (A)", the IPOE agrees with the EPC team's conclusion that it is low risk.

The latest update of the report, based on helicopter survey, re-interpretation of geological data and the Radar Interferometry Data, provides a detailed analysis of the Right Bank "Potential Landslide" (B). As a result, this potential landslide is no longer considered as a high risk for the Project. The IPOE notes that EPC's arguments are convincing and meet the IPOE's preliminary view on this subject: no pre-existing unfavourable structure exists, hypothetical unfavourable jointing

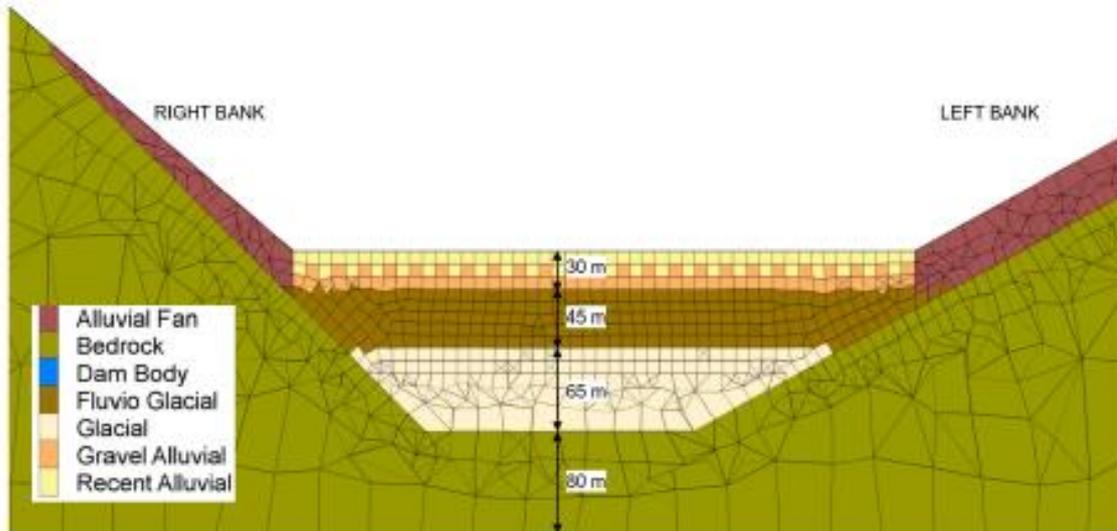
Figure 1 Soil Strata - Cross section at the valley floor

A geological model adopted by the EPC Contractor for the seepage analysis in the valley floor is shown in Figure 1. below.

In the Stage II - Part 1 report the IPOE recommended that the EPC Contractor drill complementary investigation boreholes in the foundations of the right abutment to confirm a conservative geological model has been used in the analysis. We understand that BH-R-150-2 is being drilled in the right abutment; it has reached about 80m depth and is yet to confirm the depth to the bedrock.

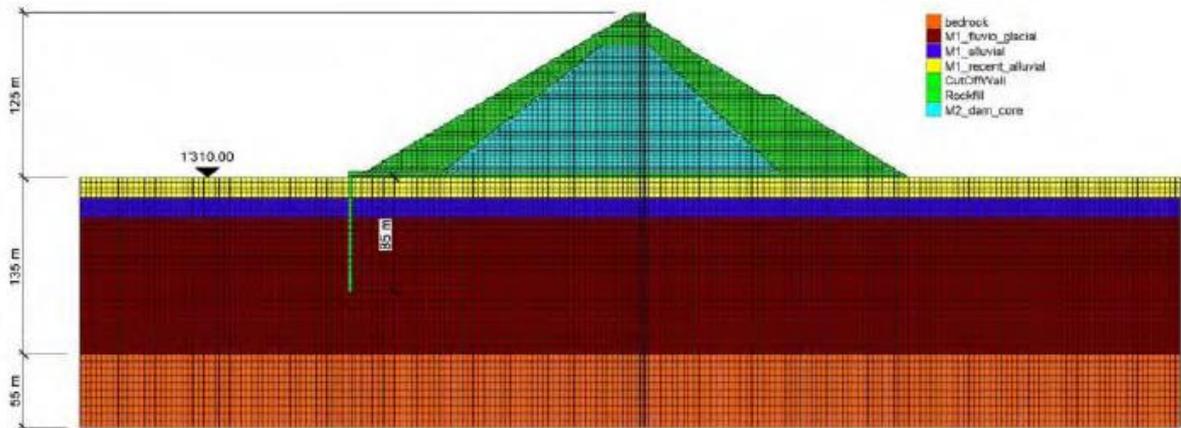
Figure 2 Dam Section

A model of the embankment in the valley section, used in the seepage analysis by the EPC team, is shown on Figure 2. below.

The Dam design includes a diaphragm cut-off wall below the upstream toe of the main Dam body in the valley floor and a grout curtain in the abutments to prevent excessive foundation seepage and the risk of internal foundation erosion. Based on the IPOE's recommendations, the EPC Designer has undertaken a seepage sensitivity analysis that resulted in an extension of the cut-off wall from its initial depth of 60m down to 85m reaching the elevation of 1225masl and going a minimum of 5m into the glacial deposits.

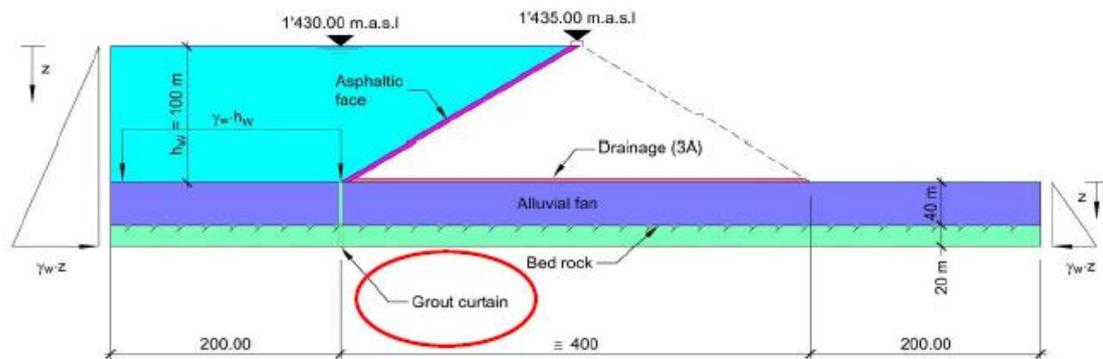
Figure 6 Seepage Model

A geological model adopted for the seepage analysis in the abutments is shown in Figure 6 below.

Permeability in the alluvial fan layer of 10^{-4} m/s has been adopted in the abutment seepage analysis; a 40m deep grout curtain has been envisaged which will have a permeability of 10^{-7} m/s.

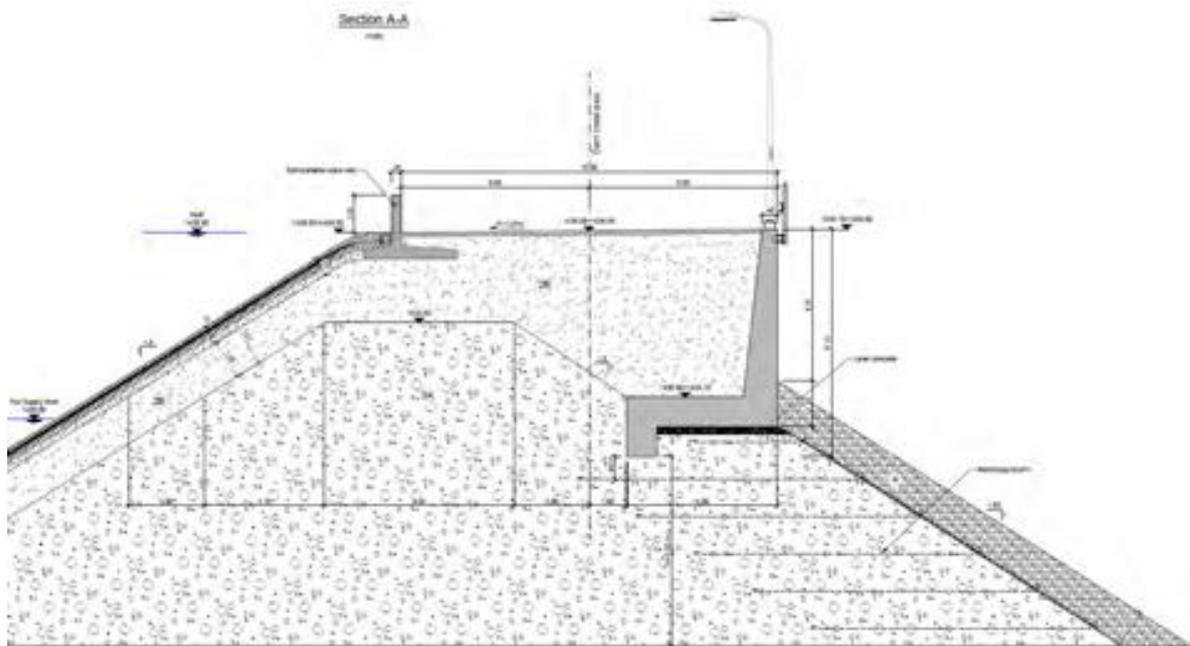
Figure 8 Crest Detail

The IPOE previously expressed its preference for an upstream slope of 1:1.7 to facilitate the construction of a high quality asphalt facing to increase confidence in the long-term performance of the Dam. The final Basic Design incorporates a slope of 1:1.6. The IPOE emphasises the importance of the use of highly specialised equipment and skilled and experienced resources to produce a high quality face and accepts the 1:1.6 slope only on this basis. As well, to facilitate any remedial works on the face over the life of the project the IPOE requires that the crest should not include a large upstream crest wall, which would inhibit ready access to the face. The crest arrangement proposed in the EPC final Basic Design shown in the Figure below is endorsed given its adjustment to the freeboard and seismic assessment matters noted below.

As shown on Figure 8 below, the final Basic Design now includes a 6m high wall constructed at the downstream side of the crest and a 1m high upstream parapet wall.

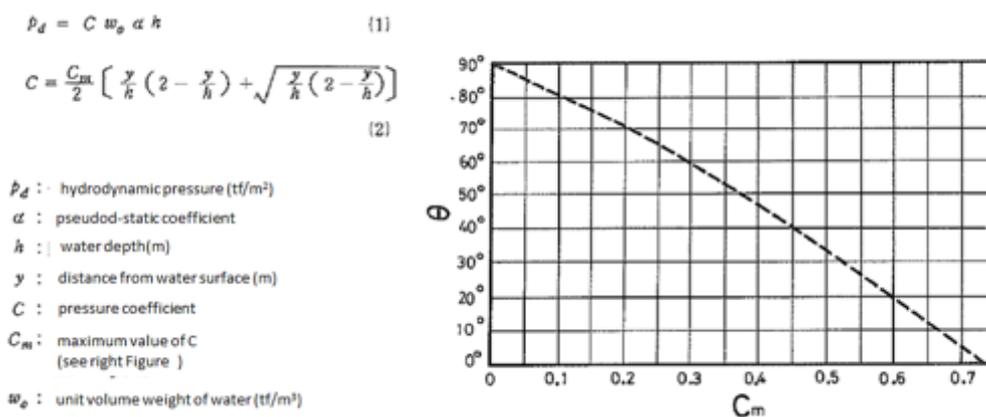
Figure 10 Zanger’s Formula

In the current analysis conducted by the EPC Designer, the hydrodynamic effect caused by an earthquake is not considered. There is, however, a probability of larger strain of the asphalt face under the water affected by the hydrodynamic pressure. Thus, the IPOE recommends checking this effect by using added mass as the hydrodynamic pressure, if possible. The added mass can be calculated, for example, by Zanger’s formula, as shown in Figure 10 below.

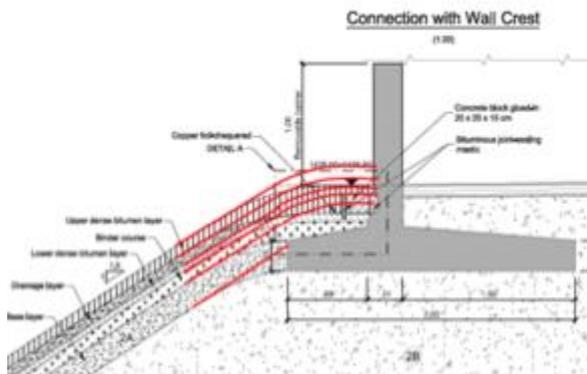
While an example of the face structure construction is shown below, it should be considered very carefully in order to alleviate the concentration of strain. The red lines indicate a potential modified shape of each layer of asphalt face and filler.

Figure 17 (Step1) Paving: Each layer of asphalt face is paved with a shape that rounds the crest shoulders.

The IPOE therefore recommends modifying the design of the face structure near the crest concrete in order to provide a larger flexibility against the displacement of the crest concrete during an earthquake.

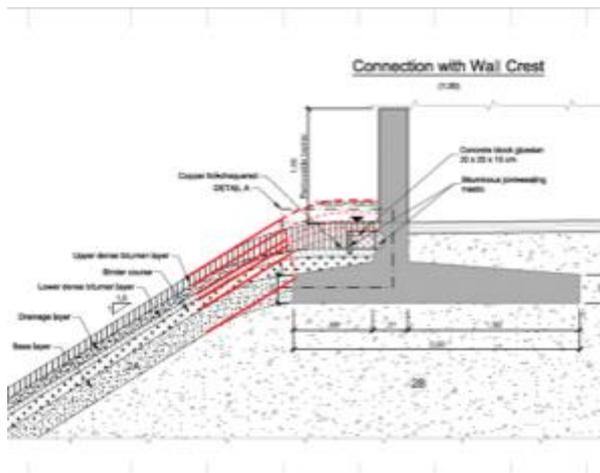
Figure 18 (Step 2) Removing: The part surrounded by the broken line is cut and removed.

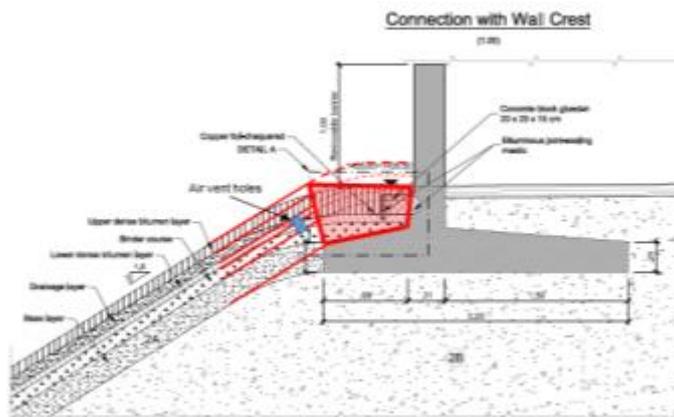
Figure 19 (Step 3) Re-filling: Filler, such as asphalt mastic, is put into the removed part

Air vent pipes should be installed above FSL at regular intervals over the full length of the dam crest for smooth drainage of leakage water. The position and direction of the air vent pipes is recommended as shown in Figure 19.

- o. To install air vent pipes above FSL at regular intervals over the full length of the dam crest for smooth drainage of leakage water. The position and direction of the air vent pipes is recommended as shown in Figure 19.

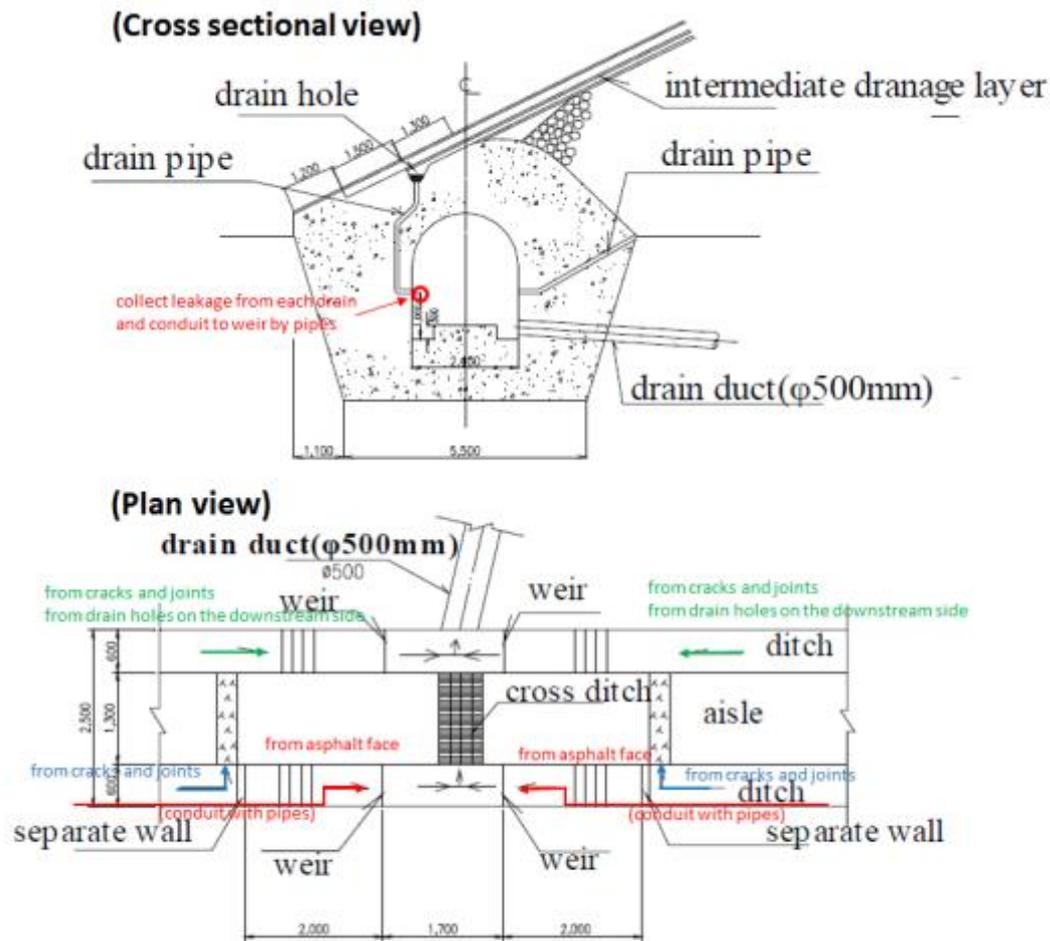
Figure. 20 Leakage measurement equipment in the inspection gallery

- 1) Facilities for leakage water measurement include:
 - a. Drainage channels on both sides of upstream and downstream in the gallery are installed as shown in Figure 20.

- 4) Measurement of water for each drainage pipe of upstream and downstream can be done manually. At Yashio Dam, 23 upstream drainage pipes in total were installed at about 10m regular intervals in the inspection gallery. This enabled easy identification of cracking positions of the asphalt face when the Tohoku Earthquake happened in 2011. Actually, the asphalt face of the Yashio Dam was cracked by the earthquake. Increase of leakage water was confirmed at three drainage pipes which were located just below the cracks of the asphalt face on both right and left banks

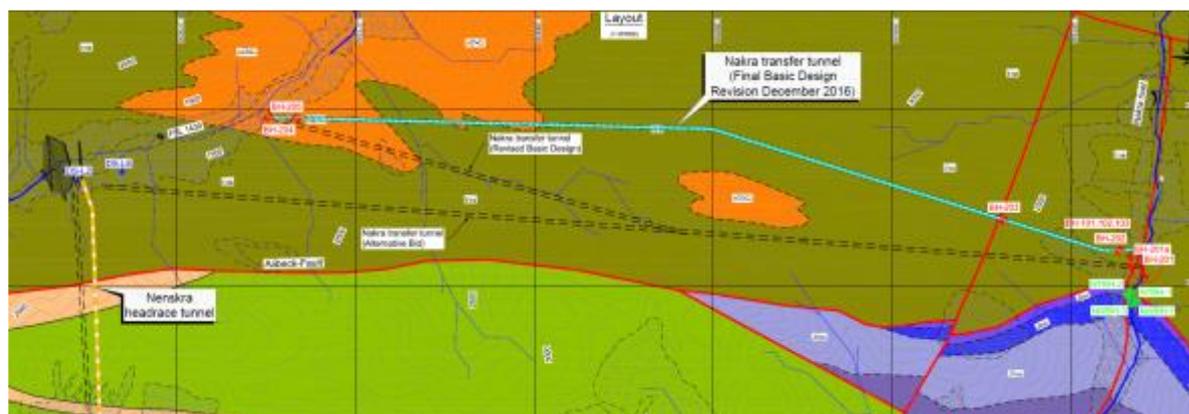
Figure 22 Alignment of TT on geological map (L-6768-B-GS-TT-GE-DW-001_000, dated 15.12.16)

Considering the general layout on the geological map (L-6768-B-GS-TT-GE-DW-001_000 dated 15.12.2016 and Figure 22) the IPOE notes that both Nakra intake and Nenskra outlet have been shifted towards upstream, while the central vertex has been shifted North, both to increase the distance to the fault and to minimize the maximum overburden.

From the geological point of view, the present alignment may be qualified as optimal, keeping in mind that the sub-parallelism of the alignment and the main geological pattern means that deficient rock mass zones, if touched by the tunnel, may still affect it over long distances. But this inconvenience cannot be avoided.
